# D10.4: Document on Test Result Analysis

PROMOTioN – Progress on Meshed HVDC Offshore Transmission Networks  
Mail [info@promotion-offshore.net](mailto:info@promotion-offshore.net)  
Web [www.promotion-offshore.net](http://www.promotion-offshore.net)

**Document Name:** Document on Test Result Analysis  
**Responsible partner:** DNV GL  
**Work Package:** WP10  
**Work Package leader:** Rene Smeets  
**Task:** 10.4  
**Task lead:** Nadew Belda

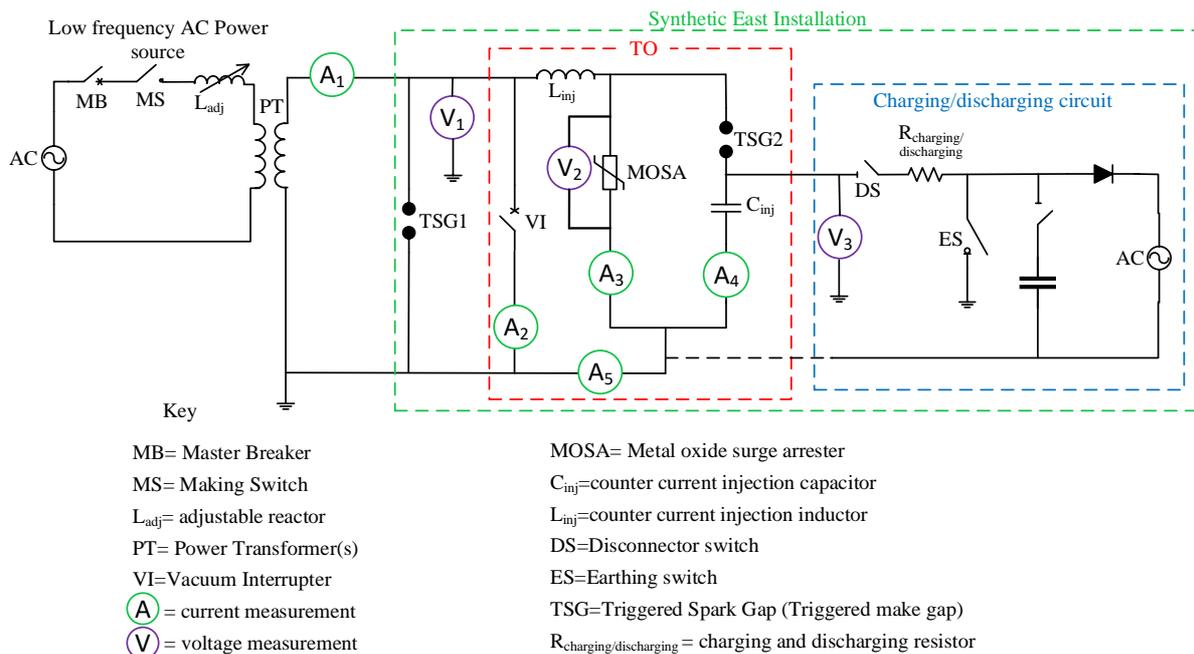
The test is set up using standard components available in the test laboratory as shown in Figure 2-1. On the left side of this figure is a power source consisting of AC short-circuit generators operated at reduced power frequency. One or more short-circuit generators are used to supply the necessary power, current and energy stresses during the test. Several short-circuit transformers are used to step-up the source voltage to the desired level in relation to the DC CB TIV rating. Next to the power transformers (PTs) is a triggered spark gap (TSG1) in parallel connection not only with the power source but also with the experimental DC CB (see red dashed box) as shown in the middle of Figure 2-1. This is intended to protect the power source and the components of the experimental DC CB against any unforeseen overvoltage conditions. Normally in a complete test circuit (planned for the test objects from manufacturers), the TSG1 is used in combination with an auxiliary AC circuit breaker (connected in series with the test object) for over-current protection. This is discussed in detail in deliverable 10.1, [1].

Figure 2-1: Single line diagram of test set-up

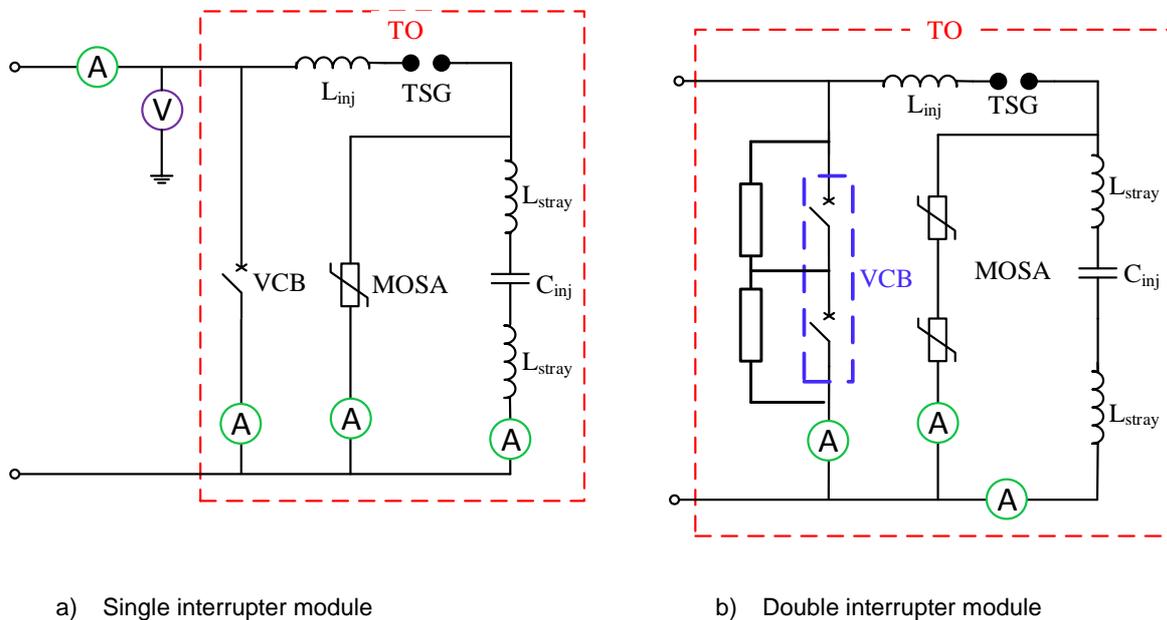
For the single interrupter case, only one out of the three poles (VIs) is used while the remaining poles are not connected to the circuit. A single line diagram for a single interrupter experimental DC CB set-up is shown in Figure 2-2a. In order to double the voltage rating (thus, the TIV) of the experimental DC CB, two VIs are connected in series as shown in Figure 2-2b. To ensure the doubling of the TIV, two series connected MOSA stacks are used. The current rating remains the same as for the single interrupter case. Nevertheless, the charging voltage of the injection capacitor, the capacitance and the inductance in the injection branch are adjusted to keep the electrical stresses of the components the same as for the single interrupter case. The parameter values of the injection circuit components and the resulting rate-of-change of current through the VIs while interrupting different current duties is shown in Table 2 and Table 3 for single and double interrupter set-ups, respectively.

a) Single interrupter module

b) Double interrupter module

A single line diagram of a single interrupter experimental DC CB is described in Chapter 2 as shown in Figure 2-2a. The photo of the actual test set-up in the test laboratory is shown below in Figure 3-2 with the main components labelled on the photo. The injection capacitor is standing out of sight next to the experimental set-up.

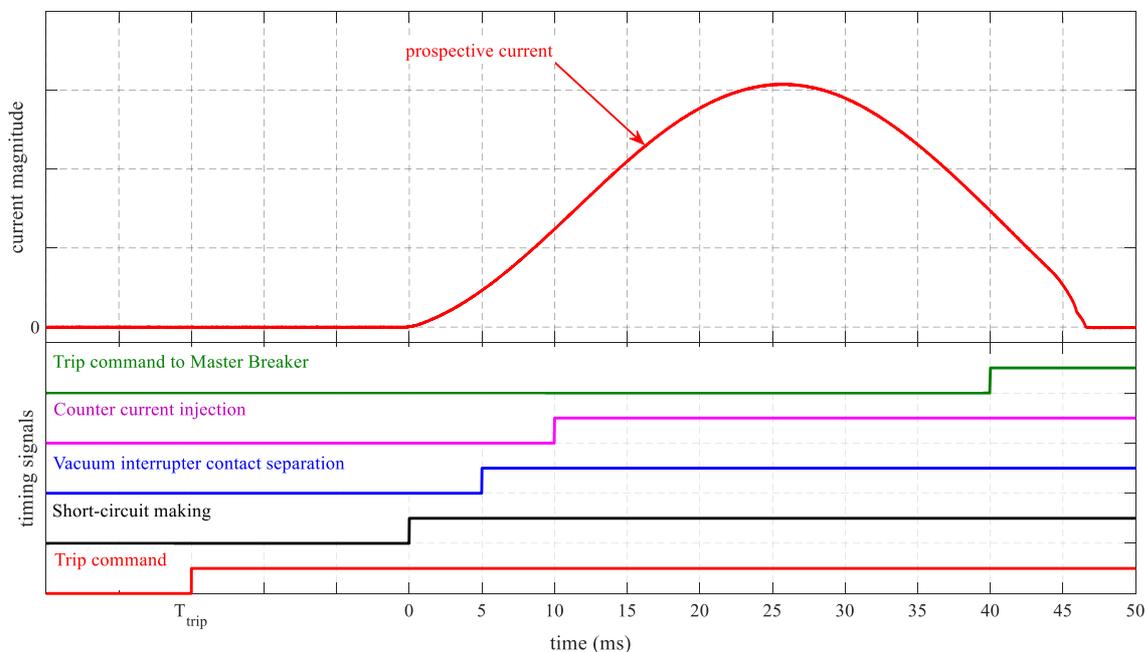
and setting the test parameters as well as the test duty current. These steps have been discussed in [1], [2] and [3] in detail and are briefly revised below for the sake of completeness of the document.

Figure 2-3: Graphical representation of test procedure and demonstration of timing sequence

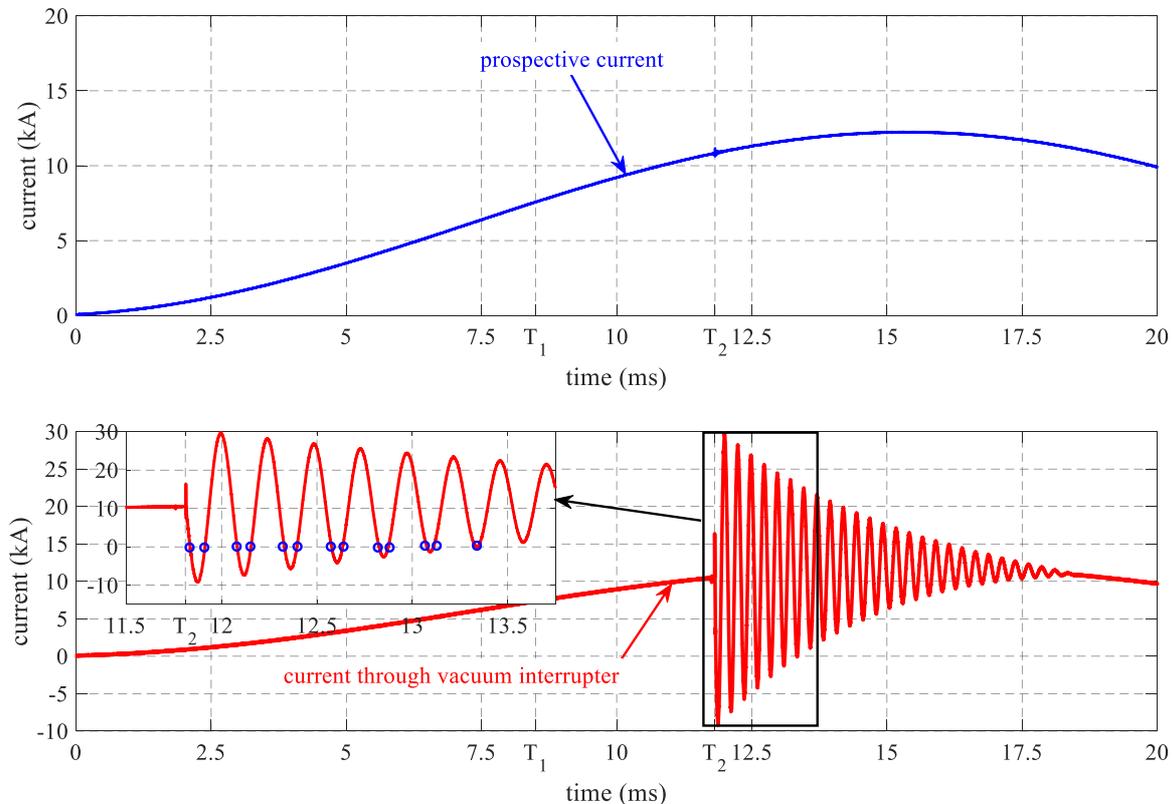
During the experimental tests, the impacts of several parameters are studied by precisely varying one or more parameter(s) at a time. Figure 3-1 shows current supplied by a test circuit and current flowing through the vacuum interrupter when a high-frequency current is super imposed from the discharge of a pre-charged capacitor. In order to show the CZCs, a zoomed in view of the current through the VI is shown. In this case the high-speed making switch represented by TSG2, see in Figure 2-1, is fired when the system current reaches 10 kA (test duty 2), thus injecting a high-frequency current. The frequency of the injection current is 4 kHz with a peak value of 20 kA ( $\pm 5\%$ ). In this case, the VI is intentionally kept in closed state. Due to inherent losses ( $i^2R$ ) the current from the injection circuit decays quickly while the system current keeps rising. This limits the number of CZCs that can be created when interrupting rising current. In the example case shown in Figure 3-1, 13 CZCs are created, i.e. the VI had 13 chances to clear the local current had it been tripped to open its contacts during this period. Current zeros are shown by blue circles in the zoomed plot of Figure 3-1. The impacts of the following parameters are investigated during the experimental test campaign.

Figure 3-1: Typical prospective current and current through vacuum interrupter when current is injected while the VI remains closed

An important observation from Figure 3-1 is that the  $di/dt$  decreases over time. This is due to decay of the injection current magnitude caused by inherent ohmic losses and also due to slight increase in the system current. Thus, if the VI fails to clear on the first CZC, the chance that it clears on the subsequent CZCs increases from the  $di/dt$  stress point of view. This is also supplemented by the fact that the contact gap distance of the VI increases in the meantime. This is discussed in the next sections.

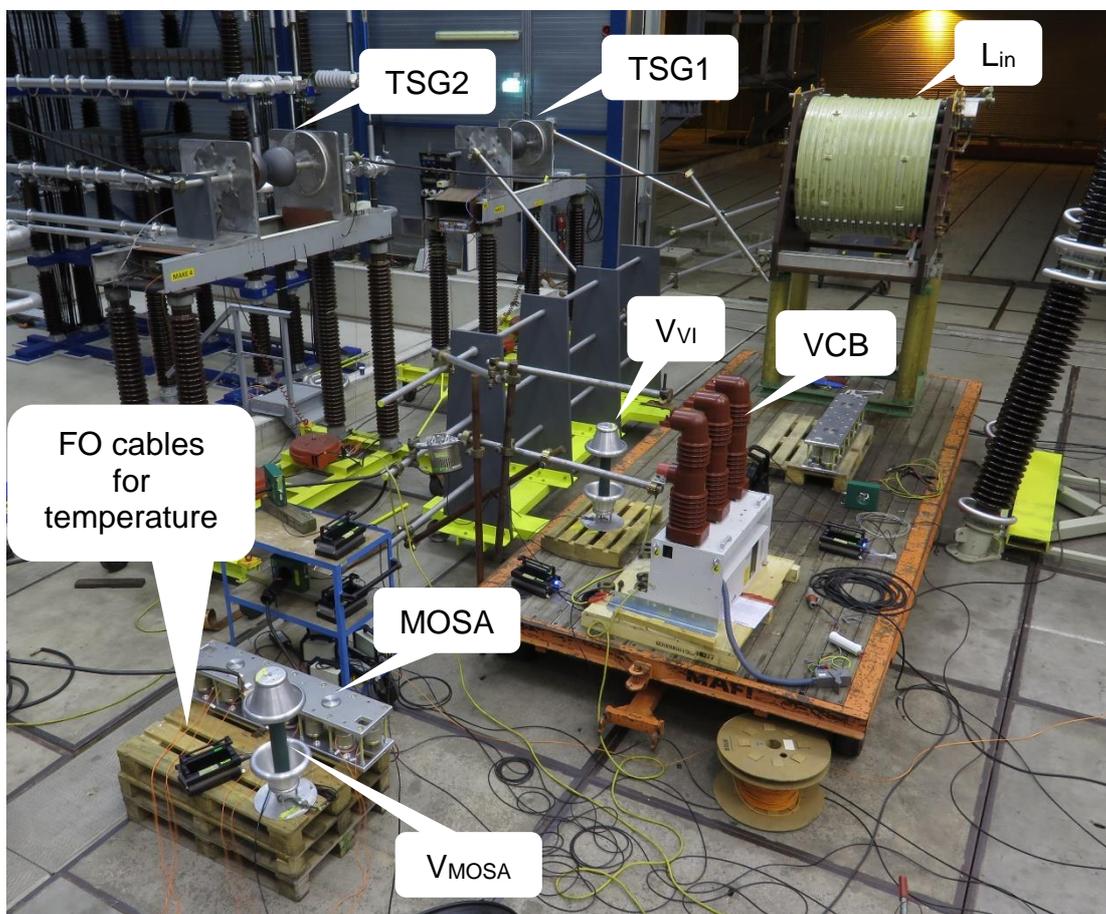
Figure 3-2: Lab set-up of a single break DC CB using VCB Type I

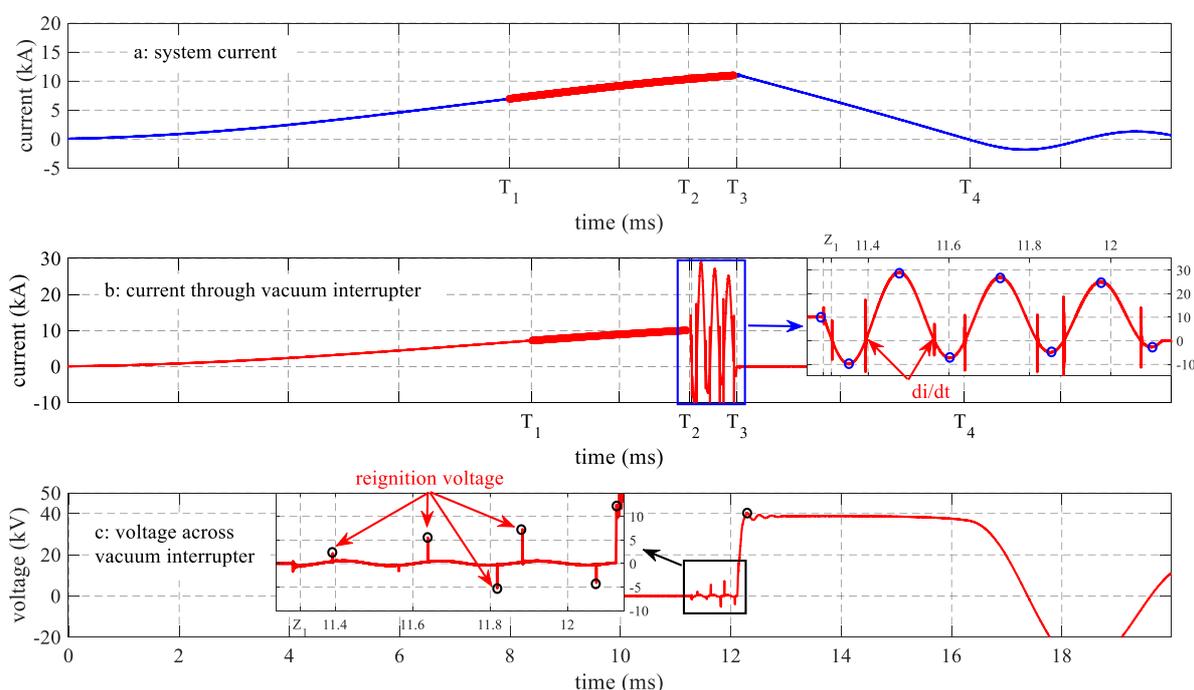
positive value and low negative value (shown by blue circles at local peaks), thus resulting in major loop and minor loop currents between successive CZCs. This seems to have a significant impact on the likelihood of current interruption at a given CZC. Normally, the VI reignition at CZC is caused by thermal and dielectric breakdown with one cause dominating the other depending on the CZC. For example, considering a first CZC (see zoomed plots in Figure 3-3b and c), there is no observable voltage spike unlike for the other CZCs showing that the reignition is mainly caused by thermal effect. This is due to large thermal energy accumulated over the entire arcing duration until the first CZCs. By the time the first CZC is created, the vacuum arc thermal plasma still persists causing it to reignite. At a second CZC, however, a voltage spike of about 2.2 kV can be observed.

Figure 3-3: Typical test result of experimental DC CB

This means the reignition is caused not only by thermal effect but also slightly by a dielectric effect. Considering the current between the first and second CZCs in the zoomed plot of Figure 3-3b, a minor loop current flows showing limited thermal energy input to the arc burn in this period. On the other hand, between 2<sup>nd</sup> and 3<sup>rd</sup> CZCs, a major loop current with peak value of 30 kA and loop duration of 170  $\mu$ s flows. Thus, the thermal energy input into the arcing gap in this period is high causing thermal reignition at 3<sup>rd</sup> CZC. There is a small voltage bump observed at this CZC but with lower magnitude than the voltage spike at 2<sup>nd</sup> CZC despite the contact gap increase. After the 3<sup>rd</sup> CZC a minor loop current flows until 4<sup>th</sup> CZC is created. Compared to the previous minor loop, the peak value and the duration of the minor loop in this period is lower, resulting in lower thermal energy injection into the vacuum arc burn in this period. Looking at the voltage plot at 4<sup>th</sup> CZC, a relatively higher voltage spike (5.5 kV) is seen. This shows the reignition in this case is caused mainly by the dielectric voltage than the thermal energy of metal plasma in the vacuum gap. It must be noted that the dielectric reignition occurred before the full voltage (due to the remaining charge on the injection capacitor) is applied to the gap. In fact, it must be noted

here that the reignition is not caused only by a single factor at a time, but it is showing which factor is more dominant at a given CZC and why.

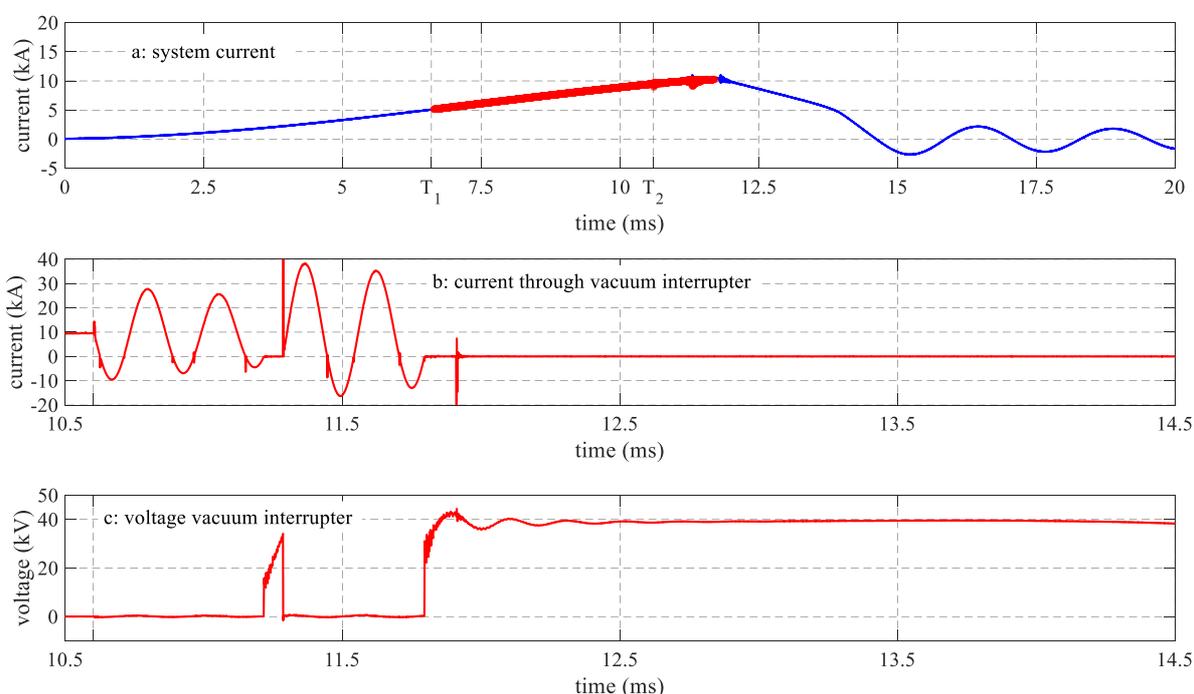
Nevertheless, it was observed on numerous occasions that the VI fails to withstand the TIV even after local current interruption. Henceforth, this kind of failure is termed as a restrike. Figure 3-4 shows a test result in which a

restrike occurred before the injection capacitor is fully charged to the protection level of the MOSA. First, the VI arc is allowed to burn for about 3.92 ms before the injection circuit triggered spark gap (TSG2) is fired to inject a counter current, see thickened red trace in Figure 3-4a. Compared to the test result shown in Figure 3-3, the VI's arcing duration is prolonged by 1 ms in this case. It is important to note that even though an increase in the arcing duration typically does not lead to current interruption at earlier CZCs, in this case the VI cleared at the 6<sup>th</sup> CZC. The interruption process follows a similar behaviour as for test result shown in Figure 3-3. The parameters near current zero are provided in Table 5. From the results shown in Figure 3-4, the VI (dielectrically) breaks down (restrikes) 70  $\mu$ s after local current interruption. Note that the restrike occurs while the TIV is rising (before the peak value is reached) as the injection capacitor is being charged by the system current.

Figure 3-4: Example case test result showing restrike of VI

Following the restrike, another string of current oscillation through the VI is observed. Since at the restrike the injection capacitor is charged to a higher voltage than its pre-charge level, the magnitude of the injection current and hence the current through the VI is higher than the oscillation before the restrike. As a result, the parameters near current zero change, for example,  $di/dt$  near CZC is increased by almost 50 % in this case and so are the peak values of the loop currents (see Table 5). At this point, the VI contacts are still moving apart, resulting in a slight successive increase in dielectric strength with each CZC. Hence, after a restrike, the current interruption occurred a few CZCs later at a higher  $di/dt$  compared to the current interruption before the restrike. In fact, in both cases, interruption happened after a minor loop current. It must be noted that from the system point of view, the oscillating current through the VI is not observable. The system does not see whether the VI cleared on 1<sup>st</sup> CZC or not. The system current continues to rise until the VI clears, resulting in a slightly higher peak current than expected. This has an impact on the energy absorption of the MOSA as well.

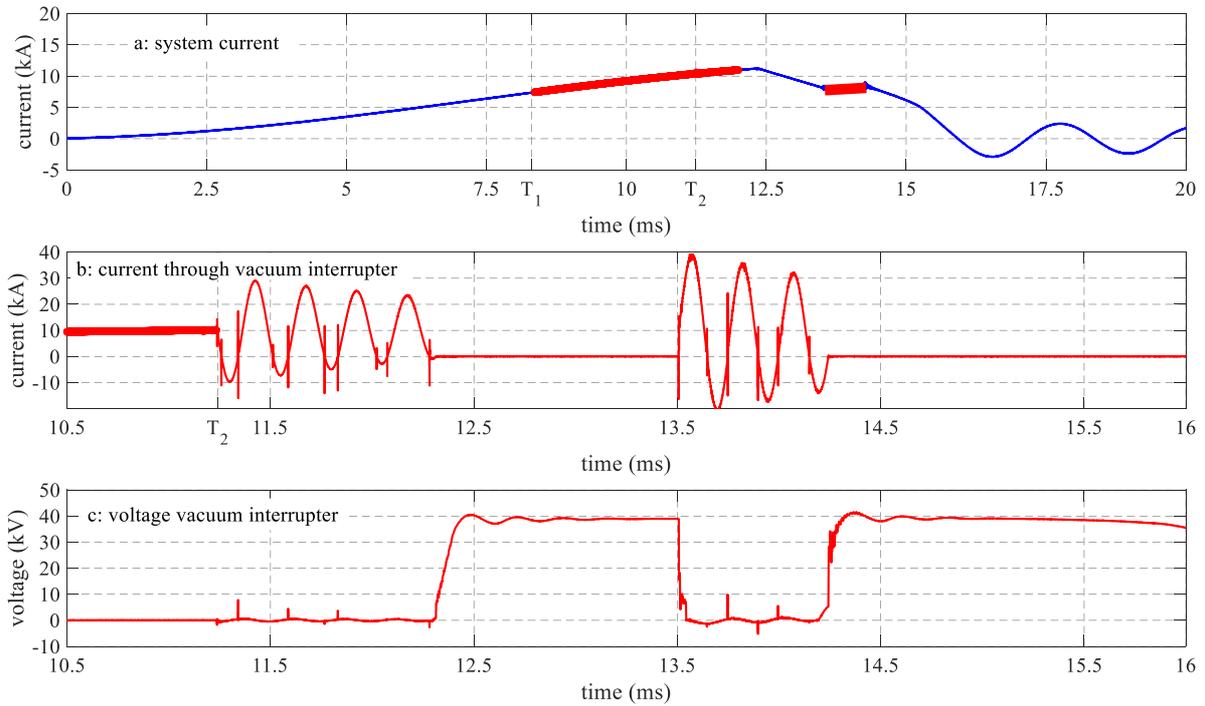
Due to the inherent behaviour of the VI, a restrike(s) may occur at a later stage even after sustaining the peak TIV for some time. Figure 3-5 depicts a typical test result in which a restrike occurred during the current suppression phase. Similar phenomena as for the previously discussed test cases, such as reignition voltage spikes at CZCs following minor loop current, are observed. Current interruption occurred at the 10<sup>th</sup> CZC in this case. The parameters near CZCs including the CZCs after the restrike are shown in Table 6.

Figure 3-5: Example case test result where VI restrikes on steady state TIV

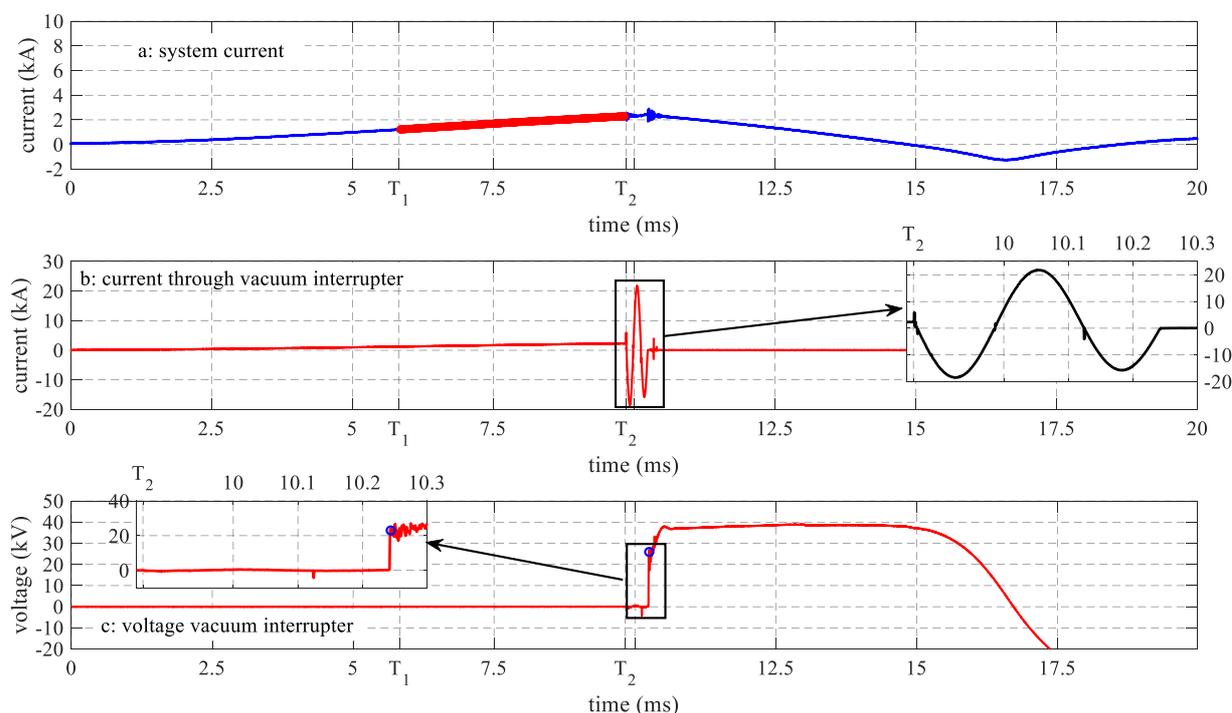
As mentioned earlier, given counter injection current peak value and frequency, the parameters near CZCs depend on the magnitude of interruption current. For example, the  $di/dt$ , the minor loop current peaks and durations are higher while the major loops current peak and duration are lower compared to when interrupting high current, see Table 7. A more striking difference, in addition to increase in  $di/dt$ , is the initial TIV at CZCs. The full ITIV may not be observed at reignited CZCs. The higher initial TIV is due to significant proportion of charge remaining on the injection capacitor since only slight discharge is needed to create CZ when interrupting low current. Thus, compared higher current interruption cases where the thermal reignition plays a major role, for low current interruption, the increased  $di/dt$  and initial TIV play a major role whether a reignition occurs at a CZC.

Figure 3-6: Example test case showing low current interruption

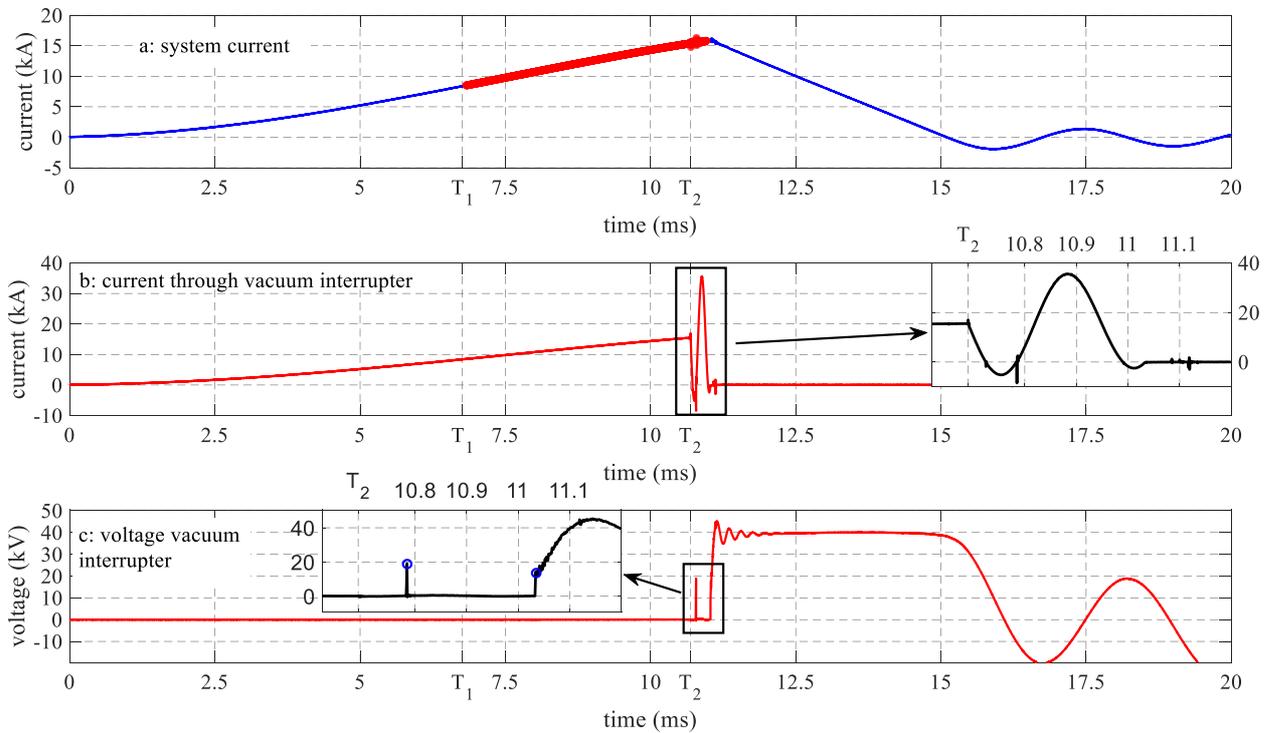
Figure 3-7 shows a high-test duty current (15.5 kA) interruption by a VI. The vacuum gap is allowed to arc for 3.96 ms before the counter current is injected as shown by the red, thickened trace shown in Figure 3-7c. Due to the high thermal energy input to the vacuum arc, no interruption at the 1<sup>st</sup> CZCs is observed. In a few cases interruption occurred at the 2<sup>nd</sup> CZC. In the example test case shown in Figure 3-7, the VI attempts to clear at the 2<sup>nd</sup> CZC where reignition occurred due to the ITIV of about 19 kV. In this case, the VI could sustain the voltage until the entire ITIV is applied. There is no observable interruption attempt by the VI on the 3<sup>rd</sup> CZC mainly due to high thermal energy following the major loop current of 35 kA peak and 200 μs duration, see Table 8. Current interruption occurred at 4<sup>th</sup> current zero following a minor loop current of 2.4 kA and about 42 μs duration. The ITIV observed at this CZC is 14.3 kV and the VI could withstand it. Following local current interruption, the capacitor keeps charging up to the peak TIV of 45 kV. Another observation is that at CZCs of high current test duty, the di/dt is lower, see Table 8.

Figure 3-7: Example case test result showing high test duty current interruption

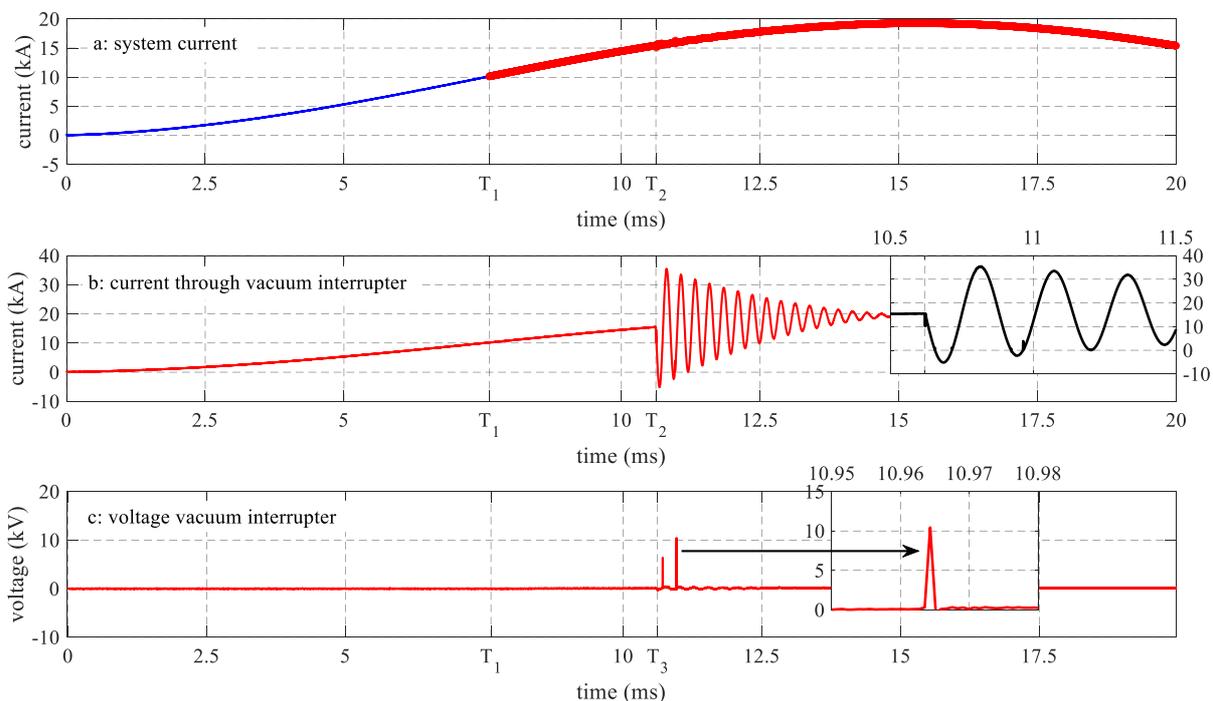
The same test is repeated 10 times and in about 40 % of the cases it failed to interrupt. Figure 3-8 shows a failure to interrupt case. Here, the arcing duration until current injection is set to 3 ms. It can be seen from the voltage plot that the VI attempts to clear at the 2<sup>nd</sup> and 4<sup>th</sup> CZCs where dielectric reignition occurred. At these CZCs, reignitions occurred at 6.4 kV and 10.4 kV, respectively. The parameters near CZCs for this test are provided in Table 9. These parameters are very similar to the test case shown in Figure 3-7 except the arcing duration until the 1<sup>st</sup> CZC which is shorter in this case. After 4<sup>th</sup> CZC, there is no other chance for the VI to clear as there is no CZC and hence, the VI continues to arc until the test circuit takes protective action.

Figure 3-8: Example case showing failed current interruption

Tests have been performed at shorter arcing times for the VI discussed in this section, but it could not succeed to interrupt. Even at longer arcing durations (4 and 5 ms) several failure cases have been recorded showing the limit of the VI to interrupt high current.

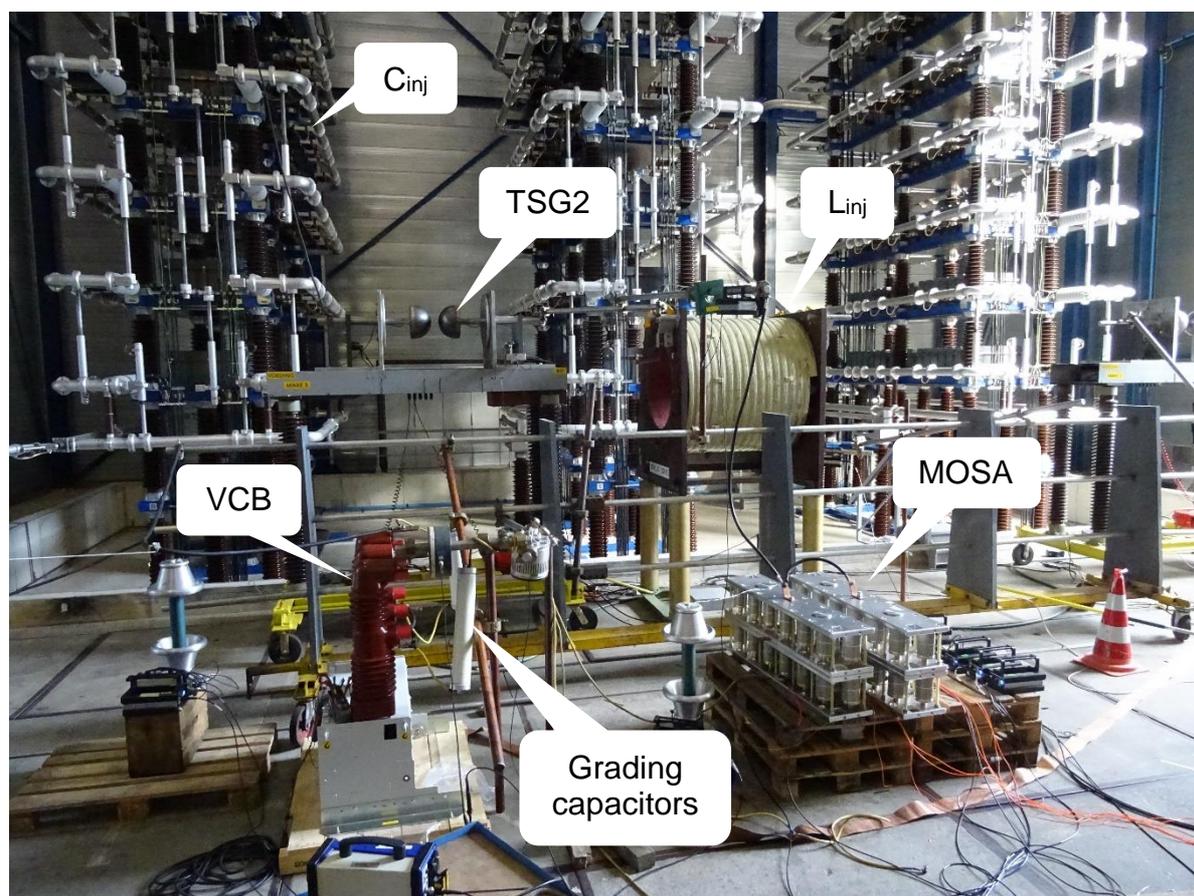
Figure 3-9 shows the photo of the test set-up of the double interrupter experimental DC CB in the test laboratory. Two MOSA stacks are used in series to double the clamping voltage of the TIV across the two VIs. For the purpose of performing a large number of tests without over-heating the MOSAs, two sets are used in parallel (for energy sharing), although this results in a slightly reduced TIV. A very critical aspect when using VIs in series (especially when using a common injection branch) is the voltage distribution. It is necessary to ensure equal voltage sharing among the two VIs in this case. For this purpose, grading capacitors are connected to each VI as shown in the figure.

Figure 3-9: Laboratory set-up of double interrupter experimental DC CB using VCB Type I

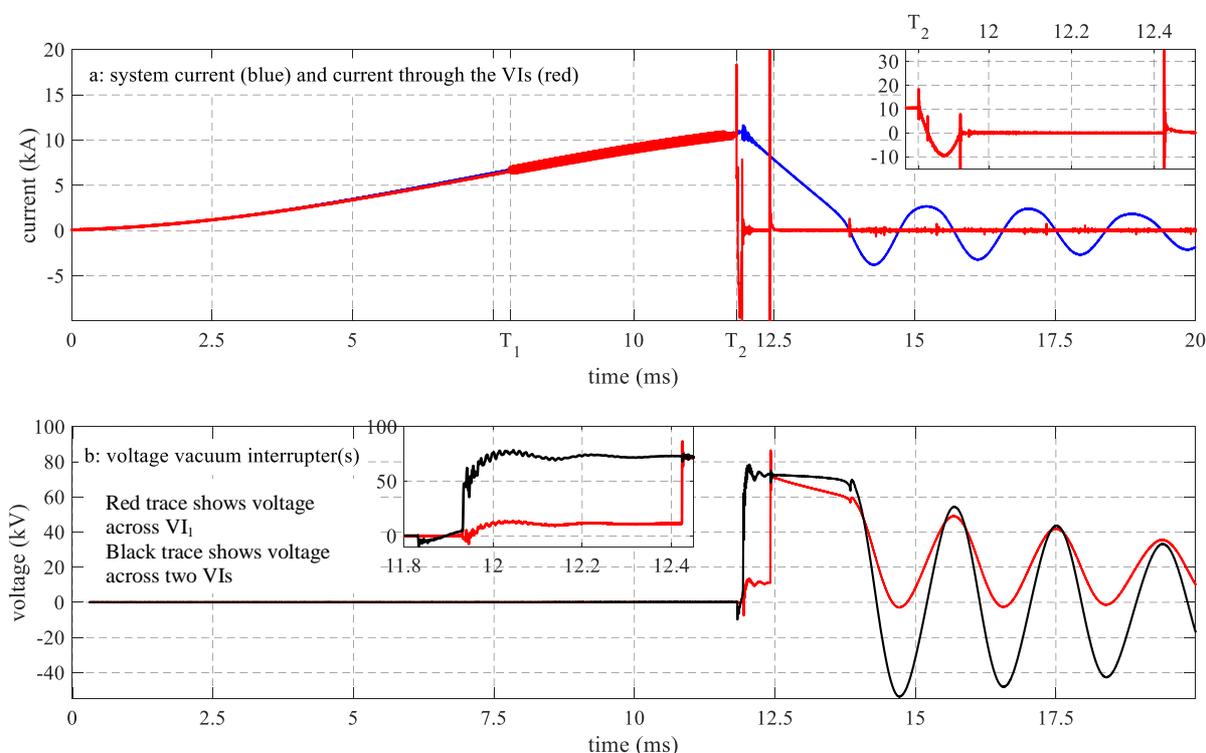
Figure 3-10 shows an example test case result by a double interrupter set-up shown in Figure 3-10 . The arcing duration until the moment of current injection is 4 ms in this case, see the thickened red trace in Figure 3-10a. The current interruption occurred on the 2<sup>nd</sup> CZC following minor loop current. A very interesting observation is, however, on the voltage measurement shown in Figure 3-10b. The black trace shows voltage measurement across both interrupters (although the voltage divider is placed a few meters away, and hence there is some induced oscillation observed) whereas the red trace shows the voltage measurement across one of the two VIs.

Figure 3-10: Example case test result by double interrupter experimental DC CB

From the voltage plots of this figure it can be seen that only one interrupter cleared on the 2<sup>nd</sup> CZC. The total ITIV measured across the two VIs is 46 kV whereas only about 6 kV followed by some transients is observed on the measurement shown by the red trace. The transient observed is due to reignition in the VI across which the voltage measurement is placed (call this VI<sub>1</sub> for convenience). Hence, only VI<sub>2</sub> cleared in this case and had to withstand the entire ITIV and the TIV afterwards. Because of the current interruption in the VI<sub>2</sub>, there is no current flow in the other VI leading to dielectric recovery in the latter. As a result, although the voltage is never redistributed equally, there is a slightly increased voltage across VI<sub>1</sub>. Nevertheless, for about 0.5 ms, more than 85% of the TIV is applied across only VI<sub>2</sub> after which a restrike occurs, just before the 12.5 ms mark on the graph. However, the restrike of VI<sub>2</sub> did not lead to resumption of the system current flow in the VIs and another set of current injection oscillation as in the single interrupter case. This is because when VI<sub>2</sub> restrikes, the TIV is redistributed to VI<sub>1</sub> as can be seen by the huge jump in the red trace, equalling the total TIV momentarily. The transient observed in the

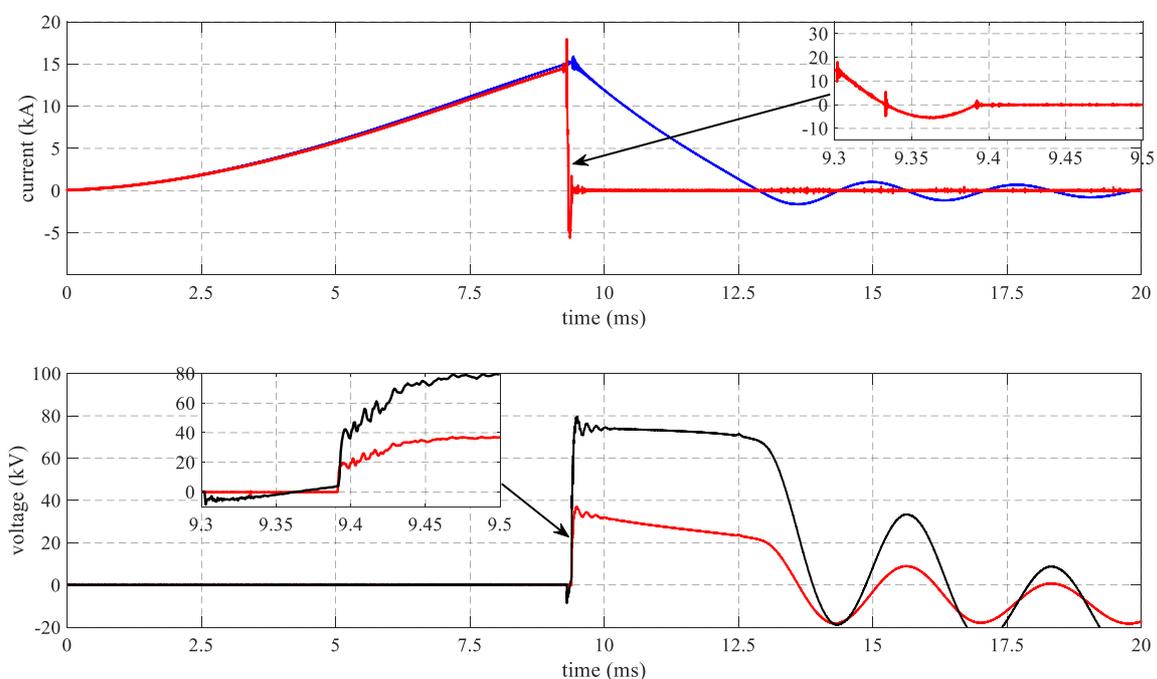
A closer look at the test results from the double interrupter DC CB shows that in most of the cases the two VIs do not clear at the same CZC and hence, the voltage distribution is never equal even if 700 pF grading capacitors are used. Only in a few cases, both VIs clear at the same CZC and in such a case the voltage distribution is better. This is shown in Figure 3-11 where the ITIV is more or less equally distributed. In addition, due to stray capacitances to ground, the VI on the high potential side is found to be carrying the higher proportion of the TIV.

Figure 3-11: 16 kA current interruption by double break experimental DC CB – typical voltage sharing issue

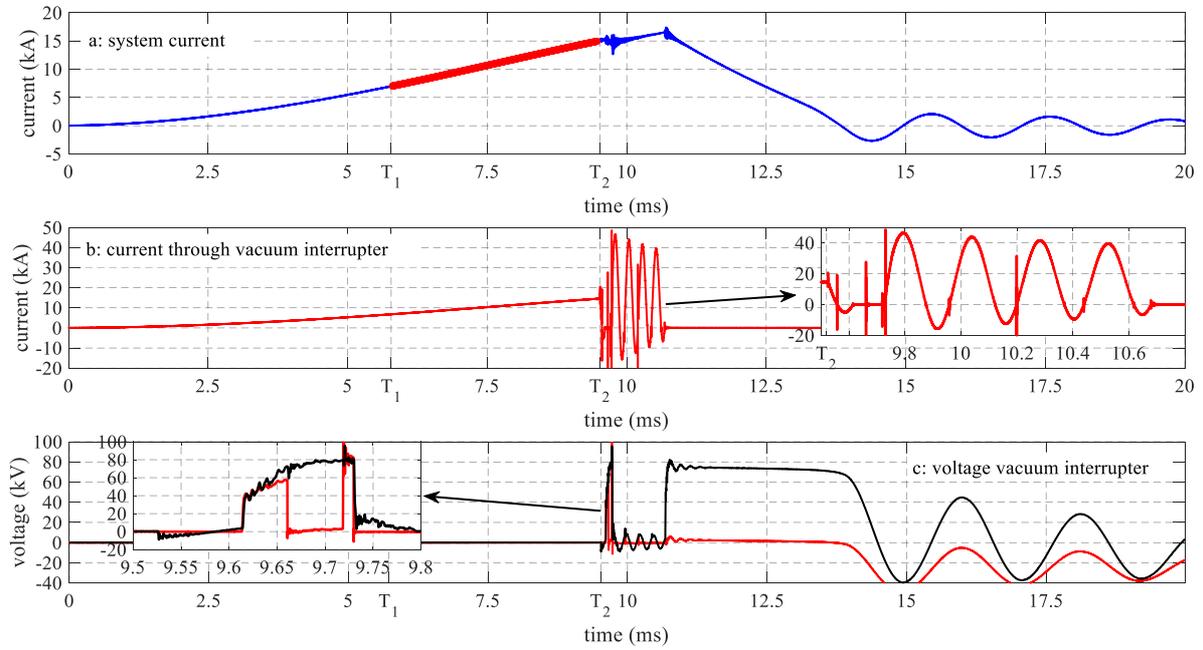
Figure 3-12 shows typical test result in which the impact of non-simultaneous clearing by series connected VIs and hence, unequal TIV sharing is observed. In this case VI<sub>1</sub> cleared on 2<sup>nd</sup> CZC while VI<sub>2</sub> did not, as observed from the voltage traces. The entire TIV is seen across VI<sub>1</sub>. About 47.2 μs later a restriking occurred in VI<sub>1</sub>. However, with a similar reasoning as in the example shown Figure 3-10, VI<sub>2</sub> could take over the TIV from the VI<sub>1</sub>.

In this case the VI<sub>2</sub> could not sustain the TIV for a long duration and it restrikes about 58 μs later. At this time, the VI<sub>1</sub> has recovered its dielectric strength and hence, could take over the TIV back. In the meantime, the TIV is rising as can be observed from the zoomed part of Figure 3-12b. However, this time the VI<sub>1</sub> sustained the TIV for a very short duration (12 μs) after which it restrikes for the second time. At this stage the VI<sub>2</sub> is dielectrically not ready to withstand the TIV and as result the system current flow re-establishes through both VIs with the superimposed discharge from the injection capacitor. With a similar reasoning as for a single interrupter case, the peak magnitude and duration of the oscillating current through the VIs is increased by about 50 %. After 8 CZCs

current interruption occurred but only  $VI_2$  cleared in this case. This can be observed from the voltage traces shown Figure 3-12b.

Figure 3-12: 16 kA current interruption by experimental DC CB – Typical voltage sharing issue

A very similar situation as the example discussed in Figure 3-12 is observed during test duty 2 (10 kA) current interruption as depicted in Figure 3-13. In this case the  $VI_1$  cleared at 10<sup>th</sup> CZC and could withstand the TIV for about 200  $\mu$ s after which a restriking occurred. Then  $VI_2$  could take over the TIV for about 33  $\mu$ s after which it re-struck. After  $VI_2$  re-struck, both VI could not clear the current even if 18 CZCs were created.

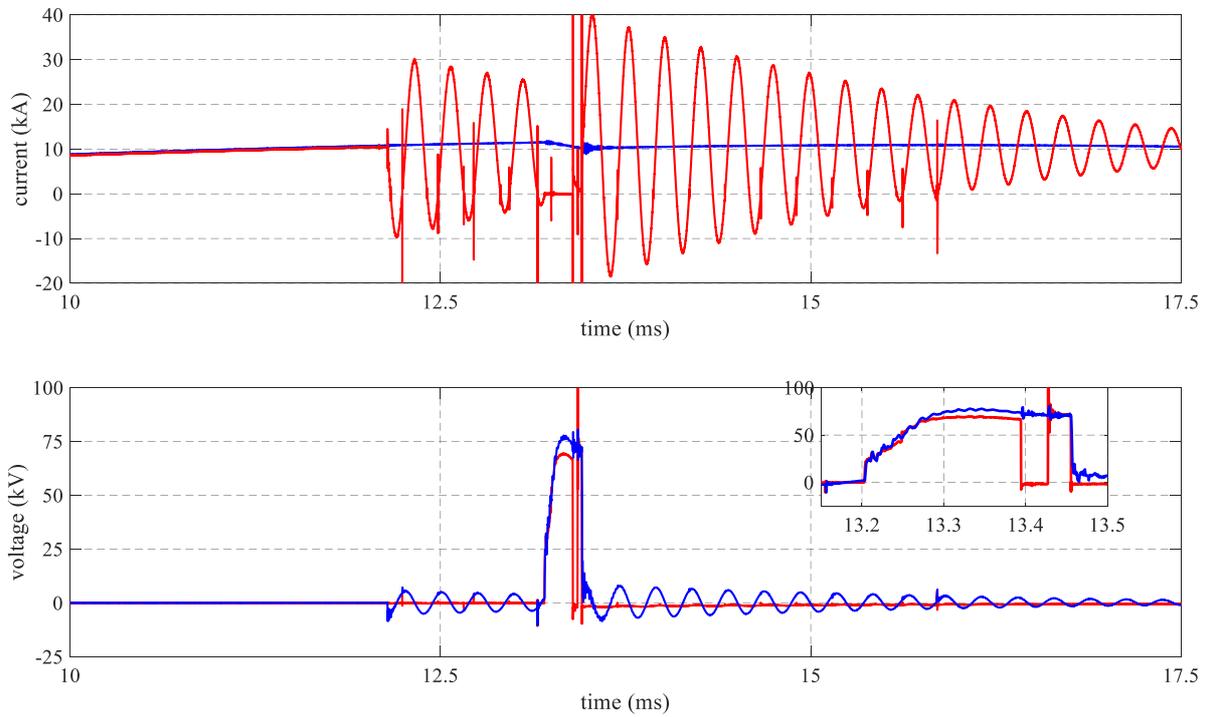
Figure 3-13: Example case test result showing failure to interrupt test duty 2 (10 kA) current after restrike by double interrupter DCCB

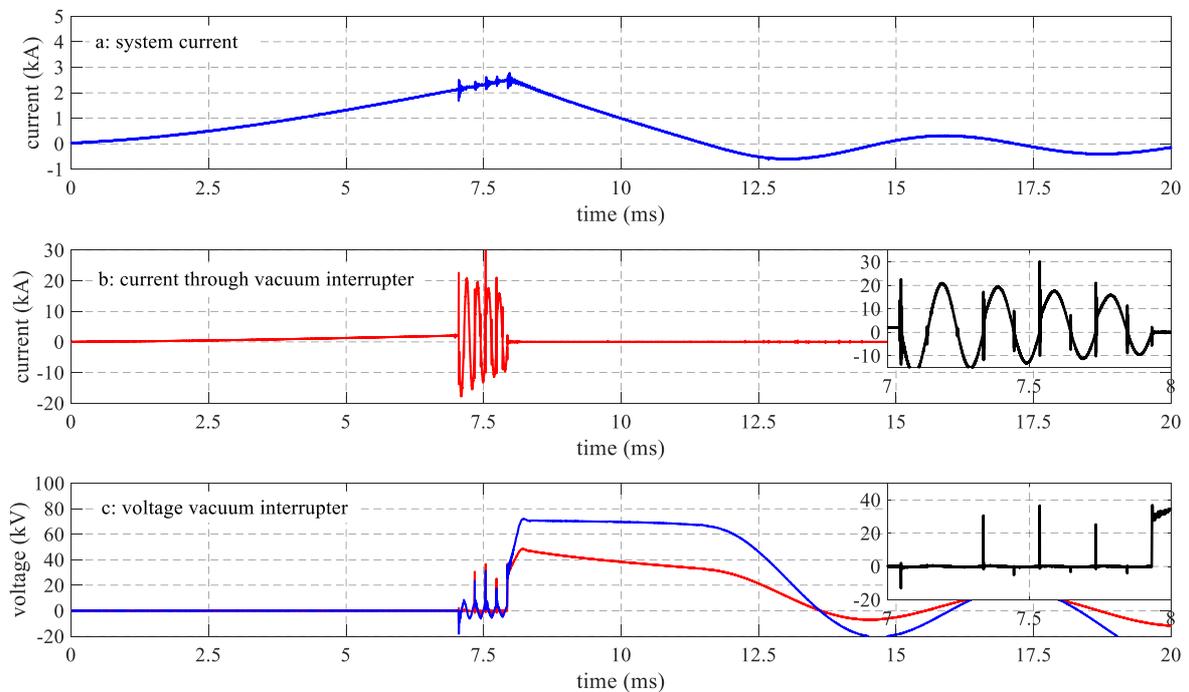
Figure 3-14: Example case showing low current interruption by double interrupter experimental DC CB

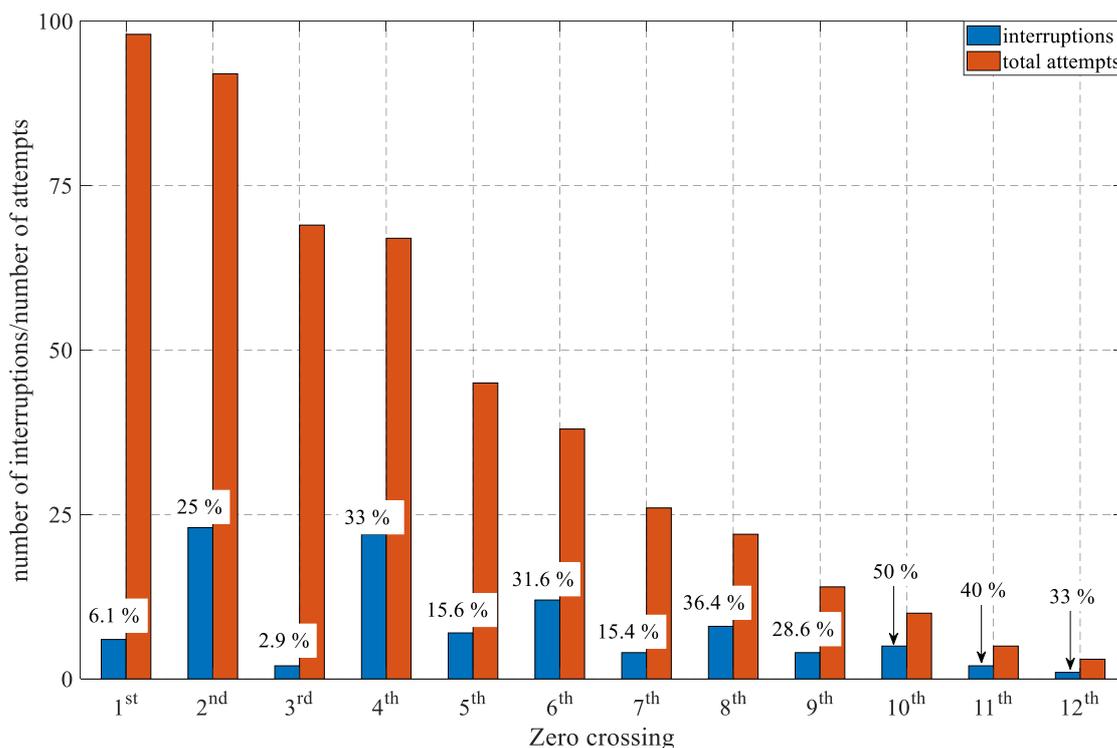
Figure 3-15 shows the distribution of current interruptions against the number of CZC for all tests done on a particular type of VCB. This data combines test results for both single interrupter and double interrupter cases using VCB type A. Of the total of 98 tests performed, only in 6.1 % of the tests could it clear at the 1<sup>st</sup> CZC. The performance increases at the 2<sup>nd</sup> CZC to 25 % of the remaining 92 tests (since in 6 tests cleared at 1<sup>st</sup> CZC). The proportion of successful current interruptions at the 3<sup>rd</sup> CZC drops significantly to less than 3 %. This is because the 3<sup>rd</sup> CZC occurs after a major loop current flow. In general, it is clear from this graph that most of the current interruptions occurred at even numbered CZCs which occur after minor loop current flow.

Figure 3-15: Proportion of current interruption at a given current zero

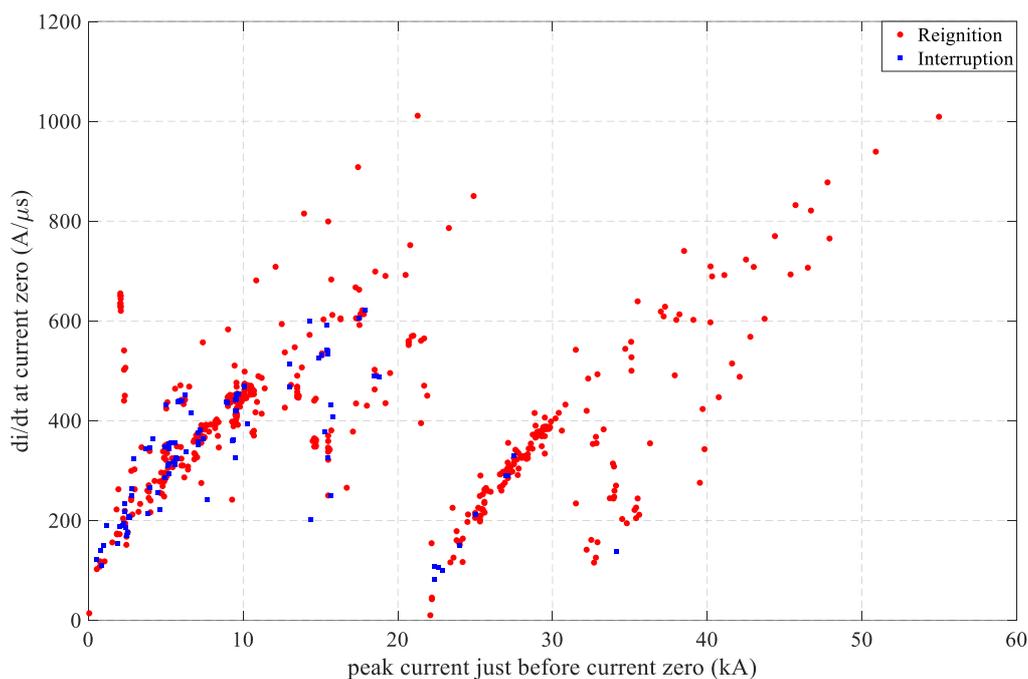
Figure 3-16 shows the rate-of-change of current ( $di/dt$ ) at a given CZC versus the peak value of current just before the same CZC both at current interruptions as well as reignitions. Looking at the x-axis which shows the current peak magnitude before CZC, two regions can be observed, below and above the 20 kA value. Most of the interruptions occurred when the peak current just before CZC is below 20 kA. Considering the region above 20 kA, there are a few cases where the VI failed to clear even if the  $di/dt$  is very small.

Another important observation is the impact of  $di/dt$  on the current interruption performance. It can be seen from Figure 3-16 that in no circumstance the VI could clear for  $di/dt$  higher than 620 A/ $\mu$ s although much higher  $di/dt$  could be created at specific CZC with very low peak loop current. Although the arc time constant of a vacuum interrupter is very short, there is a limit to it. The vacuum arc can cool from several hundreds of degree Celsius to ambient within microseconds. However, when current zero is created before the arc cools down, then reignition occurs.

Figure 3-16: current interruption in VCB Type A as a function of rate-of-change of current at current zero and current magnitude prior to current zero
