# D10.4: Document on Test Result Analysis

PROMOTioN – Progress on Meshed HVDC Offshore Transmission Networks  
Mail [info@promotion-offshore.net](mailto:info@promotion-offshore.net)  
Web [www.promotion-offshore.net](http://www.promotion-offshore.net)

**Document Name:** Document on Test Result Analysis  
**Responsible partner:** DNV GL  
**Work Package:** WP10  
**Work Package leader:** Rene Smeets  
**Task:** 10.4  
**Task lead:** Nadew Belda

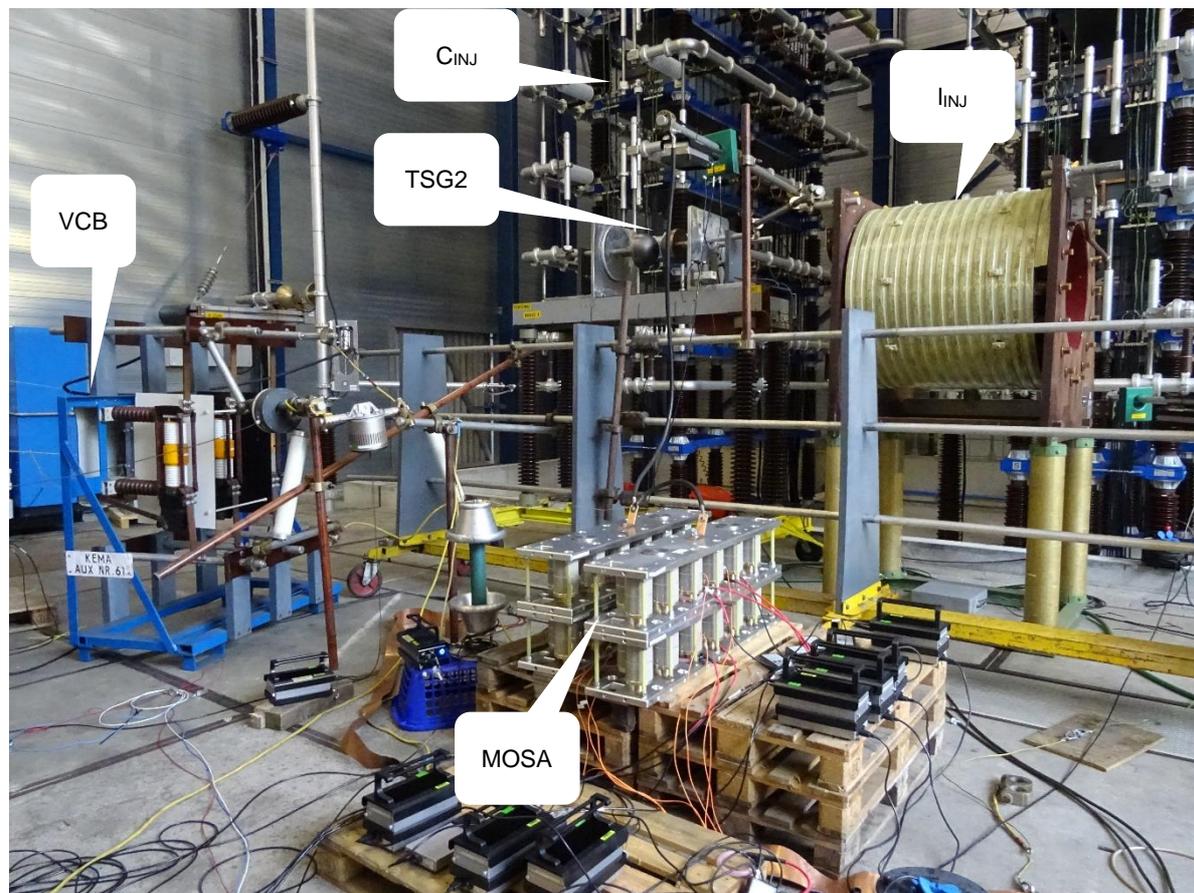
Similar tests duties were applied as for VCB Type A including the same current injection circuit. For VCB Type B the dispersion of the moment of contact separation of the VIs is significant and, thus the precise control of arcing duration is slightly challenging. The performance of VCB Type B is, however, completely different than the performance of VCB type A. In many test cases, the VCB Type B cleared the short-circuit current at the 1<sup>st</sup> CZC and, sometimes even at shorter arcing duration than VCB type A. In general, tests were performed 62 times of which on 47 occasions the VI(s) cleared on 1<sup>st</sup> CZC. Actually, of the total test shots, only 10 times the failure to clear was recorded. This slightly higher percentage failure than VCB type A.

Figure 3-17: Laboratory set-up of double interrupter experimental DC CB using VCB Type B

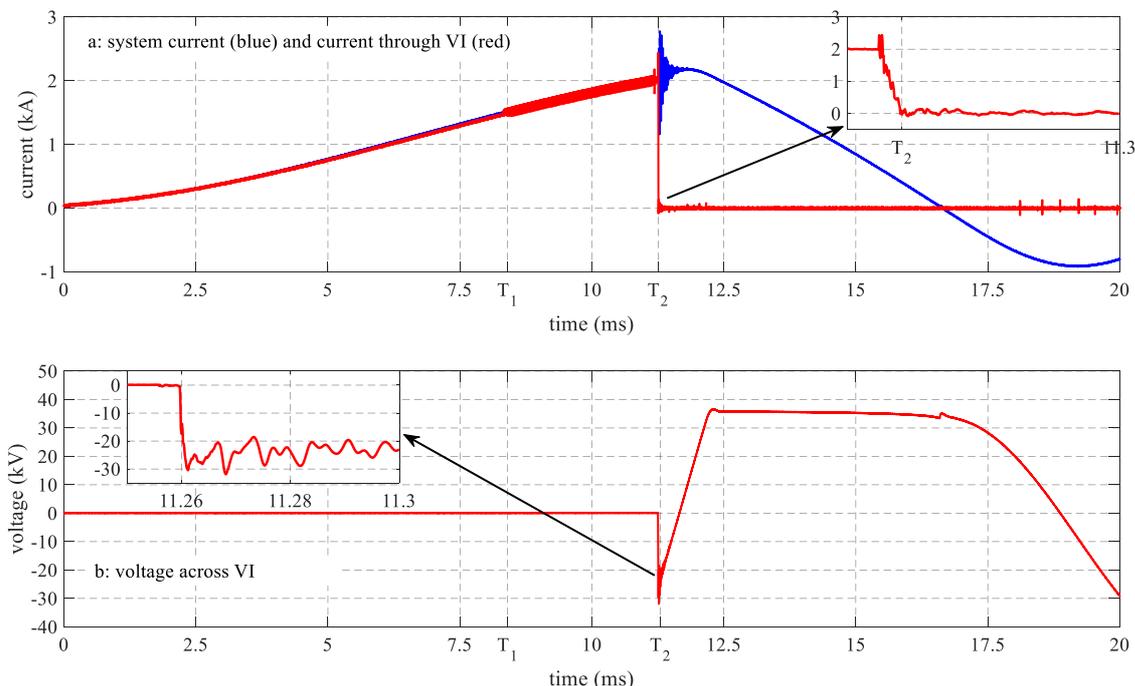
Considering current interruption with test duty 1, no failed interruptions were observed. Tests were repeated 10 times with arcing duration ranging from 2.47 to 3.15 ms and in all the cases the VI cleared on the 1<sup>st</sup> CZC. Looking at the parameters near CZC, the  $di/dt$  is about 600 A/ $\mu$ s and the ITIV is 26 kV. In no occasion has a reignition or (late) restrike been observed during the series of test duty 1 interruptions. A typical test result of a test duty 1 current interruption is shown in Figure 3-18. After current interruption in the VI, the TIV rises from around -26 kV to peak value of 36.2 kV with average rate-of-rise ( $du/dt$ ) of 0.064 kV/ $\mu$ s. The slow rate-of-rise of the TIV is due to the low system current which charges the injection capacitor after current interruption, see Figure 3-18b. The rate-of-rise is not an issue here although it is much lower than the rate-of-rise of voltage in AC (1.5-3.5 kV/ $\mu$ s, which is system dependent) rather the immediate voltage due to the remaining charge across

Figure 3-18: Typical test result using a VI of VCB Type B – Test duty 1 current interruption.

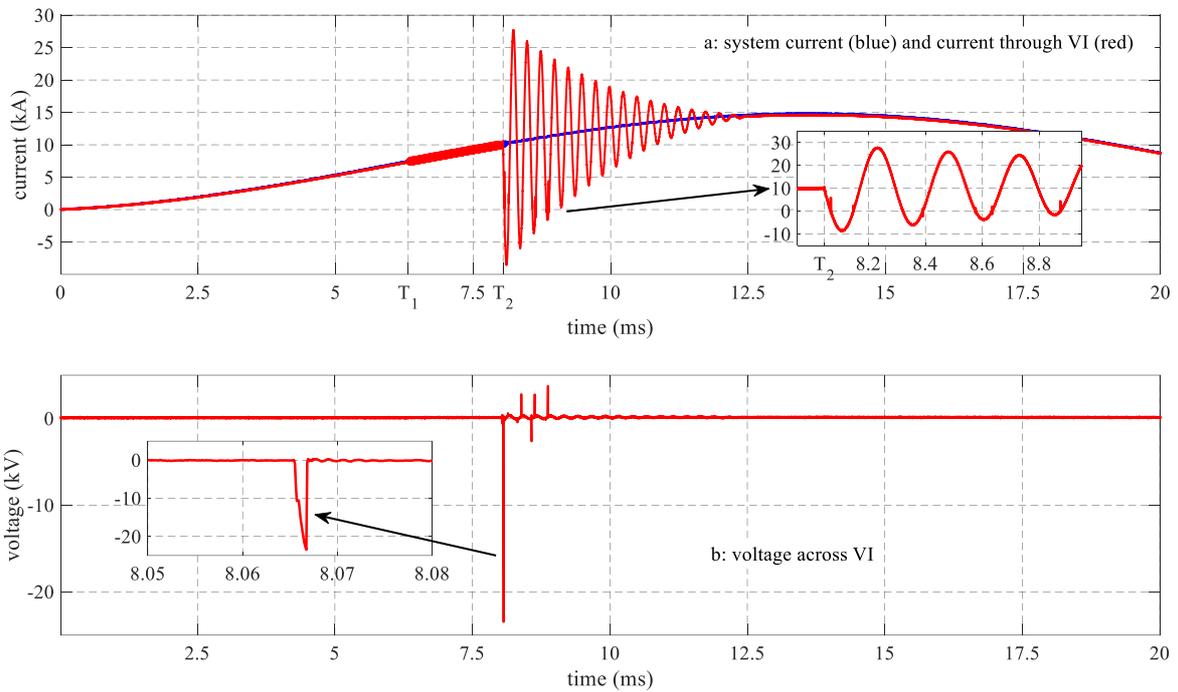
Test duty 2 (10 kA) current interruption was also performed 10 times using a single VI of VCB Type B. In 4 occasions the VI failed to clear even if up to 10 CZCs were created. Looking at the failure to interrupt test results, in all cases the failure to interrupt occurred due to too short arcing durations. This means that the VI could not achieve sufficient withstand capability in between the separated contacts during the period in which CZCs occurred. Specifically, the arcing duration until the 1<sup>st</sup> CZC was in the range from 0.33 ms to 1.73 ms although arcing duration until the last CZC is as long as 2.54 ms. Up to 10 reignitions per test are observed at this test duty although the reignition voltages at each CZCs are less than 3 kV except on one occasion where 20 kV ITIV is observed at the 1<sup>st</sup> CZC. The latter is observed for the longest arcing duration among the failed test cases, i.e. when the arcing duration until 1<sup>st</sup> CZC is 1.73 ms. The measurements showing the detail of the test result of this case is shown in Figure 3-19. An important observation from the test result shown in this figure is that the reignition voltage at later CZCs did not increase unlike for VCB Type A discussed in the previous section although some reignition voltages are observed at the subsequent CZCs.

Note that the too short arcing duration in these tests were not intentional rather it was due to the dispersion of the moment of contact separation of the VIs.

Figure 3-19: Test result showing failed interruption of test duty 2 by VCB Type B

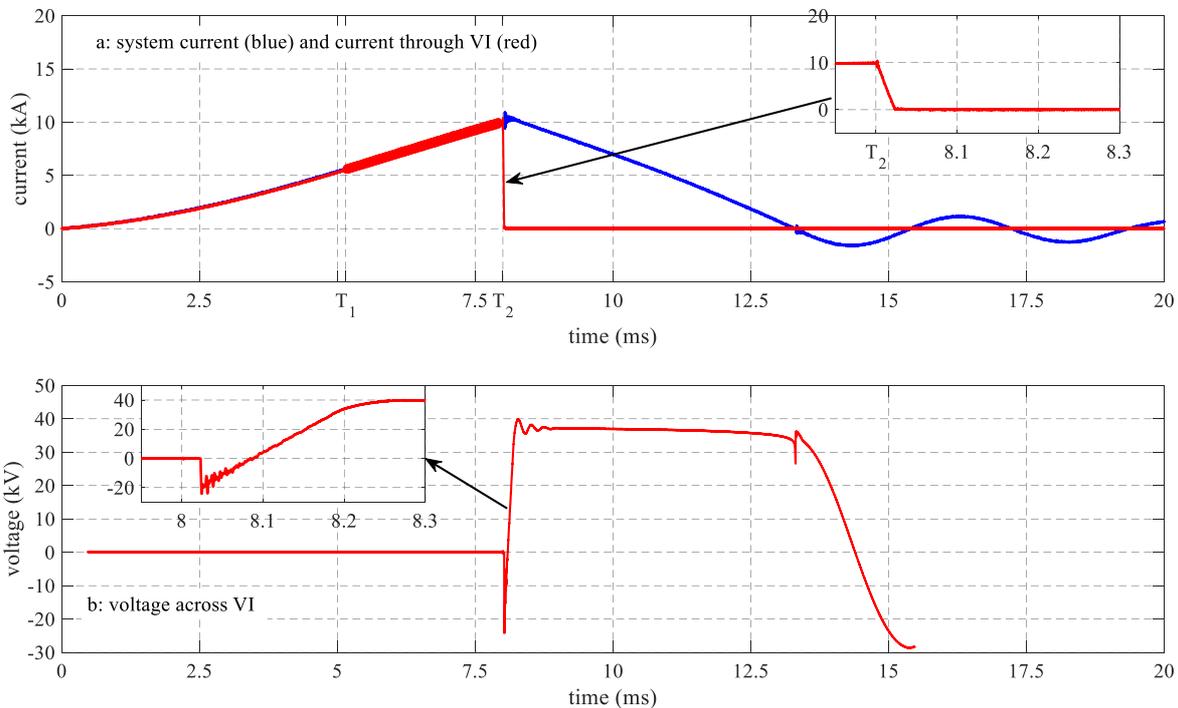
Figure 3-20: Typical test result showing test duty 2 interruption by VI of VCB Type B

Successful current interruptions are recorded in the remaining 6 test shots where in all cases interruptions occurred on the 1<sup>st</sup> CZC. In other words, all the tests in which the VI reignited at 1<sup>st</sup> CZC led to total failure to clear despite the chances at subsequent CZCs. In addition, there was no (late) restriking observed during the tests using

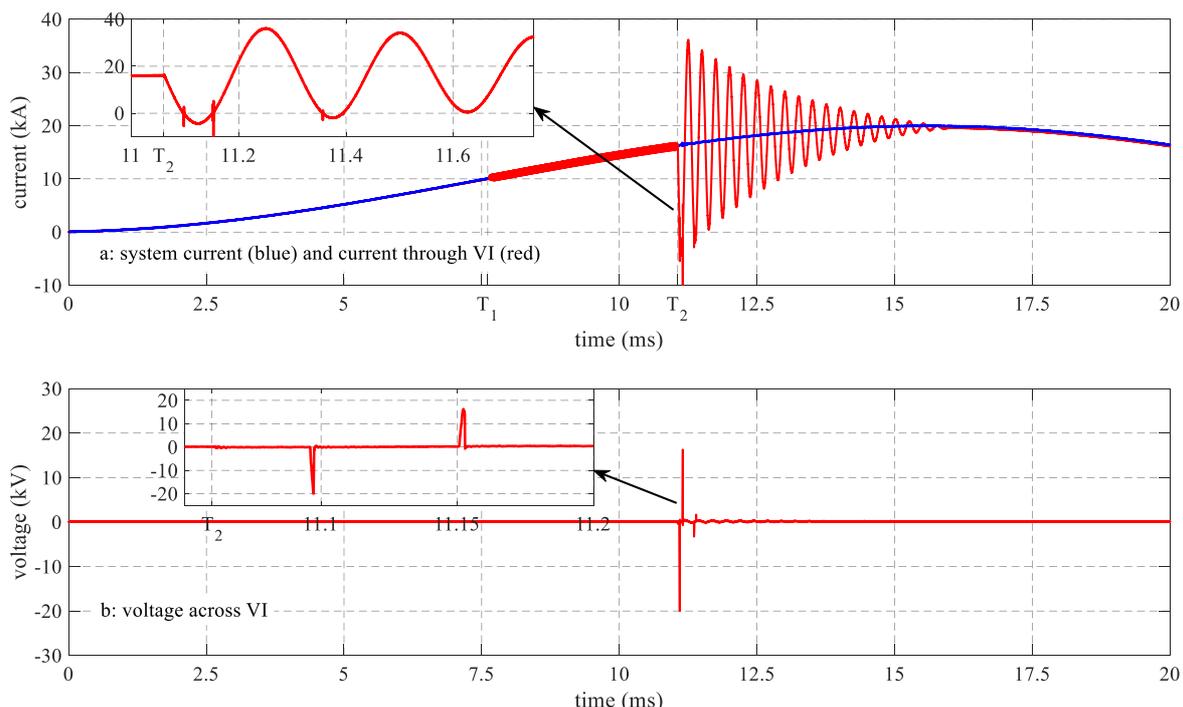
Next, the high-current test duty (test duty 3) was performed 12 times on a single VI of VCB Type B. In 50 % of the cases the VI failed to clear at this test duty even with arcing durations as long as 3.48 ms (until 1<sup>st</sup> CZC). At this test duty, a minimum of 4 CZCs are created using the injection circuit which remains the same for all test duties. Figure 3-21 shows test results of a failed current interruption of test duty 3 with arcing duration of 3.48 ms. Note that the arcing duration until the last CZC (4<sup>th</sup>) is 3.78 ms in this case. It can be seen from this figure that the VI attempted to clear at the first CZC and reignited at ITIV of about 20 kV. An attempt to clear is also observed at the 2<sup>nd</sup> CZC although the reignition occurred at a lower voltage (16 kV) than the 1<sup>st</sup> CZC. This is completely different for a VI of type A VCB where the reignition voltage is higher at CZCs following minor loop current (even CZCs).

Figure 3-21: Test result showing failed interruption of test duty 3 by VCB Type B

A general observation from the failed test results is that as the arcing duration (until the 1<sup>st</sup> CZC) increases, the reignition voltages at CZCs also increase. This confirms the VI’s attempts to clear improve with longer arcing duration. Successful current interruption was achieved when the arcing duration until 1<sup>st</sup> CZC is increased to 3.6 ms. All the tests with arcing durations longer than 3.6 ms resulted in successful interruption and, in all cases, upon the 1<sup>st</sup> CZC. The current interruption with arcing duration of 3.6 ms is shown in Figure 3-22. At the 1<sup>st</sup> CZC the di/dt is approximately 330 A/μs and the ITIV is 17 kV. The TIV rises to a peak value of 42.3 kV from -17 kV with average rate-of-rise of 0.4 kV/μs. Note the significant increase in the du/dt at this test duty compared to other test duties. Also, at high current test duty, the peak TIV is high due to V-I characteristics of the MOSA.

The main conclusion from these tests is that longer arcing duration is needed as the magnitude of test duty currents increase. In other words, for a given rated current interruption there is minimum arcing duration that needs to be ensured before CZC creation for this VI.

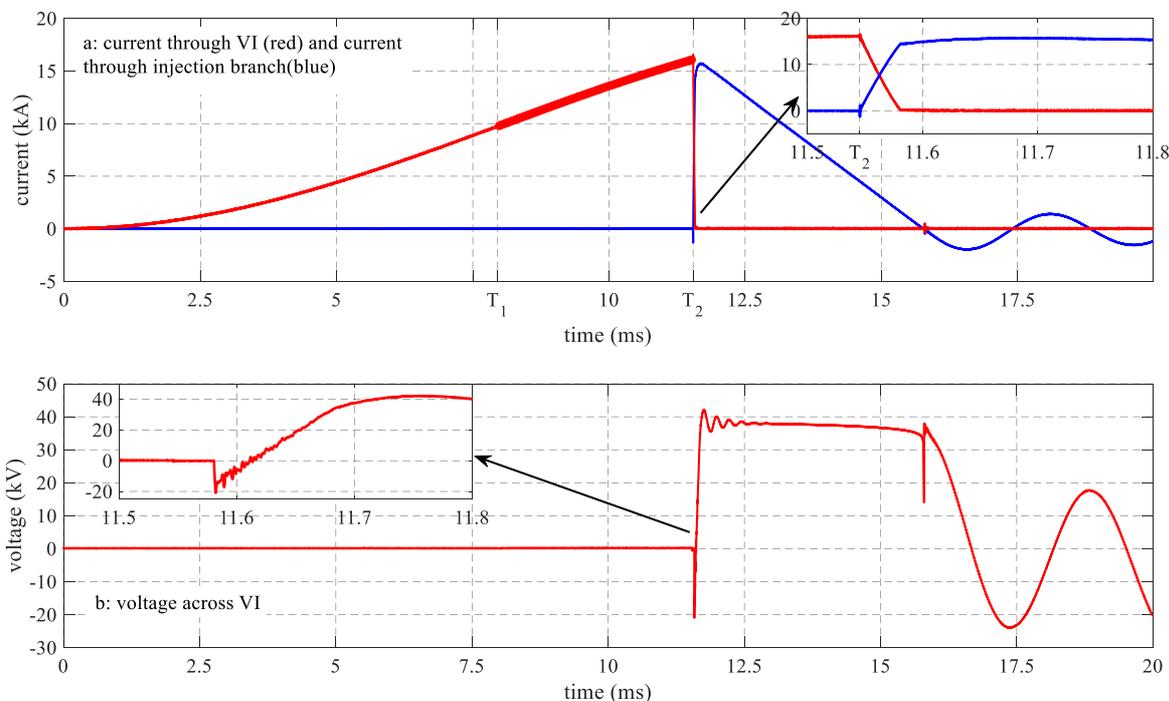
Figure 3-22: Typical test result showing successful test duty 3 interruption by VCB Type B (single interrupter)

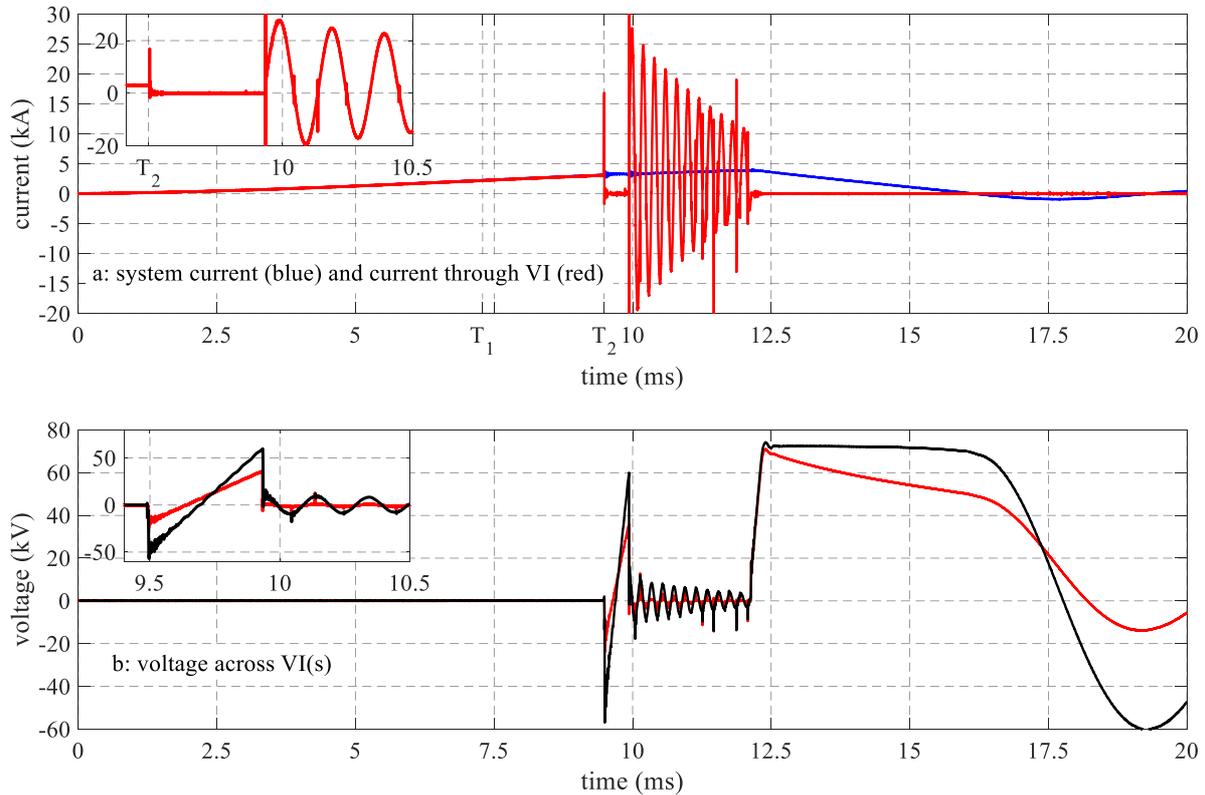
Two VIs of VCB type B are connected in series to investigate the performance at high voltage application. As for the single VI case, tests were repeated 10 or 11 times for each of the three test duties. No failures to interrupt were recorded when using double interrupter although a few reignitions and restrikes occurred at low current test duties. A critical observation during these series of tests is the voltage sharing issue between the two VIs even though 700 pF grading capacitors are placed across each VI.

discharge from the injection capacitor flows through the VIs. Several CZCs have been created until finally clearing at 22<sup>nd</sup> zero crossing. However, at the second current interruption only VI<sub>1</sub> cleared. This can be observed from the voltage traces since the two measurements overlap. After the TIV reaches its peak value the VI<sub>2</sub> starts to slightly share a portion of it during the remainder of the current suppression period.

Figure 3-23: Test duty I current interruption by VCB type B. A restrike followed by several reignitions is observed before final interruption

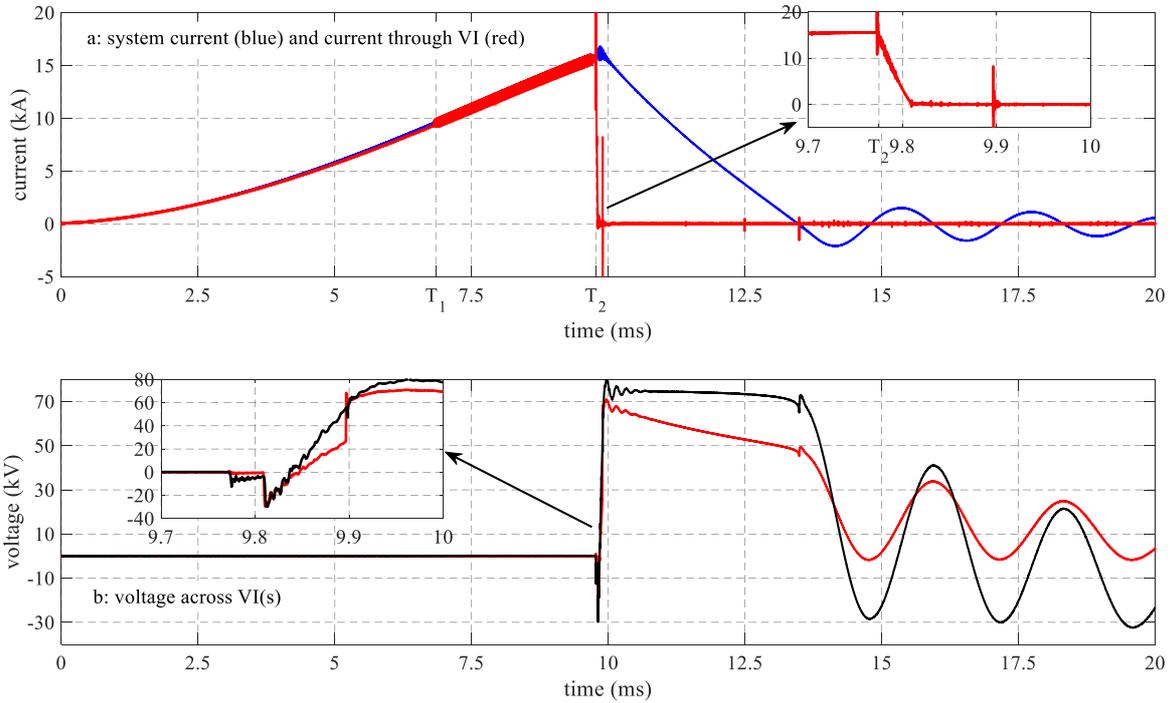
During the test duty 2 current interruption series, only in one case a reignition occurred where the VIs interrupted at the 3<sup>rd</sup> CZC. In all the other cases interruption occurred at the 1<sup>st</sup> CZC. Similarly, there was no reignition or restrike observed during test duty 3 current interruption series. Current interruption occurred always at 1<sup>st</sup> CZC even if the arcing duration is as short duration as 2.07 ms although at arcing duration less than 3.5 ms a single VI could not clear current at test duty 3. In one test case the VI<sub>2</sub> reignited after 90  $\mu$ s although this did not lead to overall reignition. This is shown in Figure 3-24. It can be seen from the zoomed section of Figure 3-24b that the VI<sub>1</sub> took over the entire TIV after the restrike in VI<sub>2</sub>. A closer look at the voltage measurements shows that initially it was the VI<sub>1</sub> which cleared upon the CZC; however, as the TIV passes through zero (going from negative to positive) the TIV redistributes across the two VIs, see the black and red trace on zoomed section of Figure 3-24b. However, the VI<sub>2</sub> restrikes when approximately 30 kV is reached across its contacts. The later observation where initially one VI clears at the 1<sup>st</sup> CZC and the voltage sharing between the two VIs starts as the TIV goes from negative to positive was common throughout all the tests using this breaker.

Figure 3-24: Test duty 3 current interruption by VCB type B

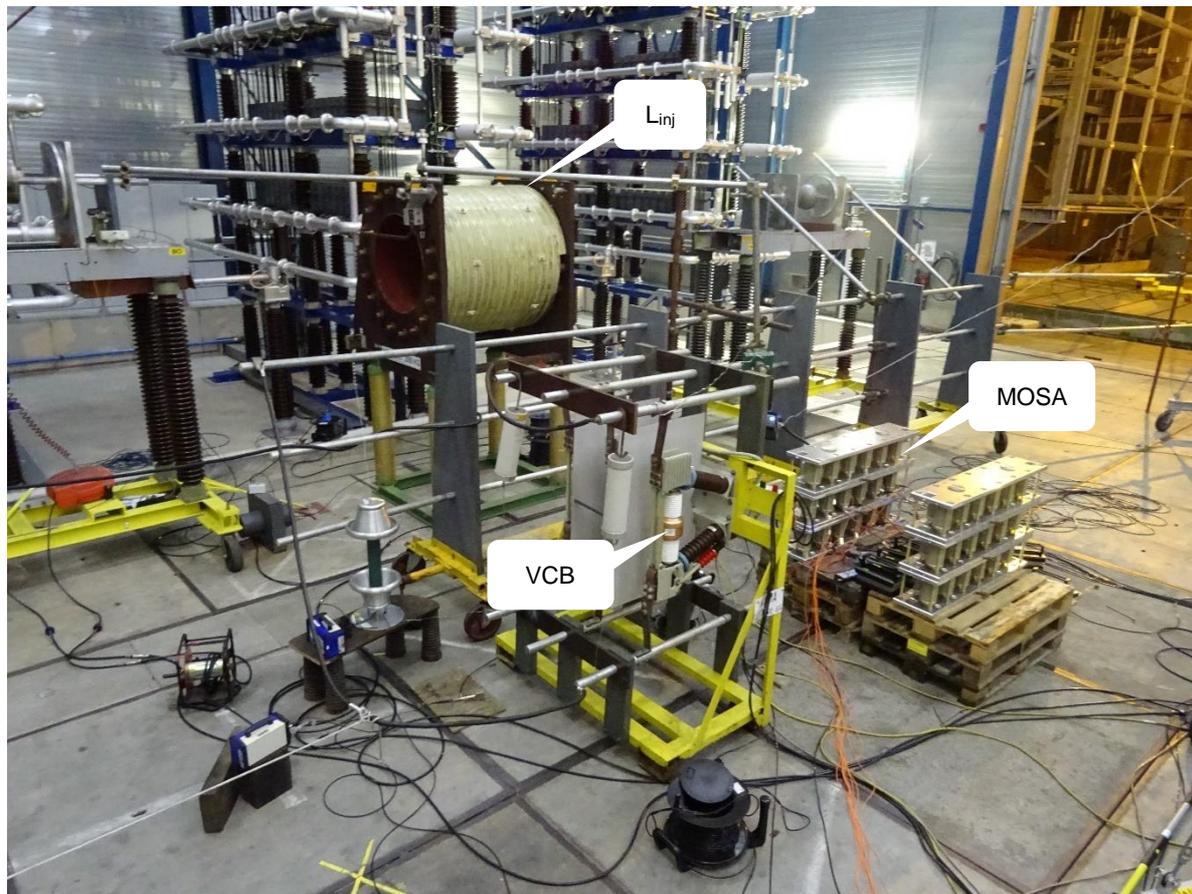
The third type of VCB (type C) is investigated in the experimental test campaign. A test setup with VCB type C is shown in Figure 3-25.

Figure 3-25: Lab set-up of experimental DC CB using VCB type C

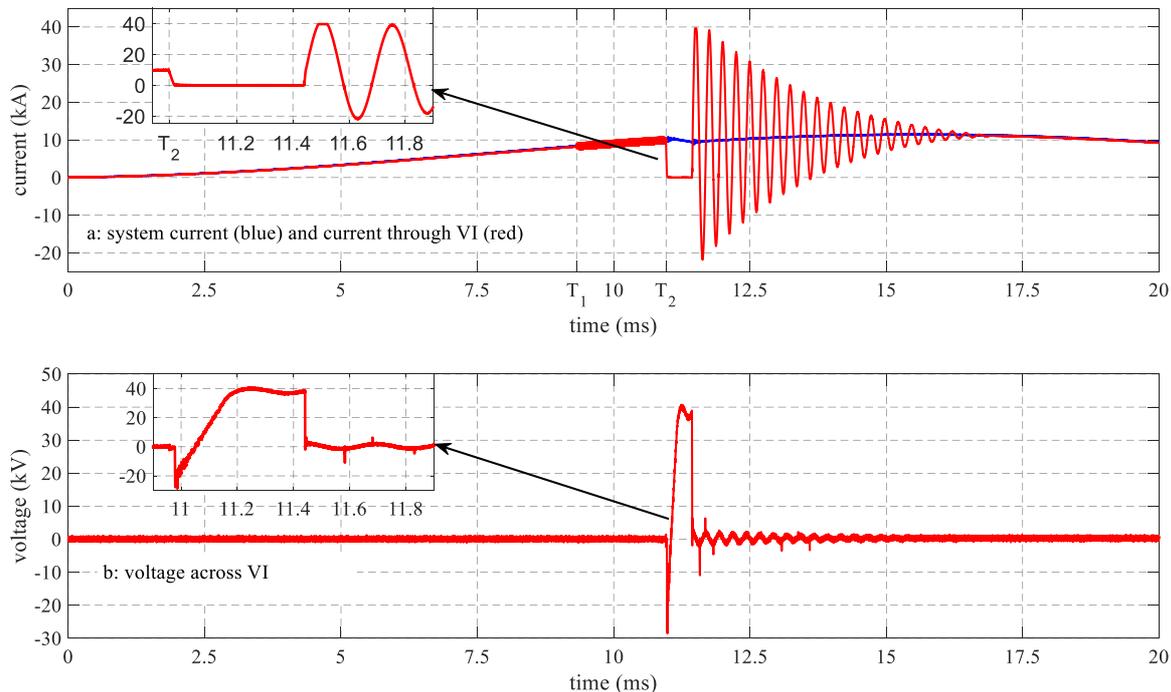
Figure 3-26 shows a test result in which a restrike occurred in the VI of VCB type C. A restrike occurred not during the test case with the shortest arcing duration, rather during the test with the longest arcing duration (1.63 ms) in the series although a restrike was also observed in another test with arcing duration of 0.44 ms. The latter is also not the shortest arcing duration in the series. In both cases the VI failed to clear after the restrike even though 18 CZCs are created. In the test case shown in Figure 3-26, the VI has been opening for about 4.3 ms until the last CZC and it failed to clear. Similar phenomena, that the VI(s) fail to clear after reignition at the 1<sup>st</sup> CZC or after a restrike, were observed for the double interrupter tests using this VCB.

Figure 3-26: test duty 2 interruption by single VI of VCB type C. Restrike during current suppression period

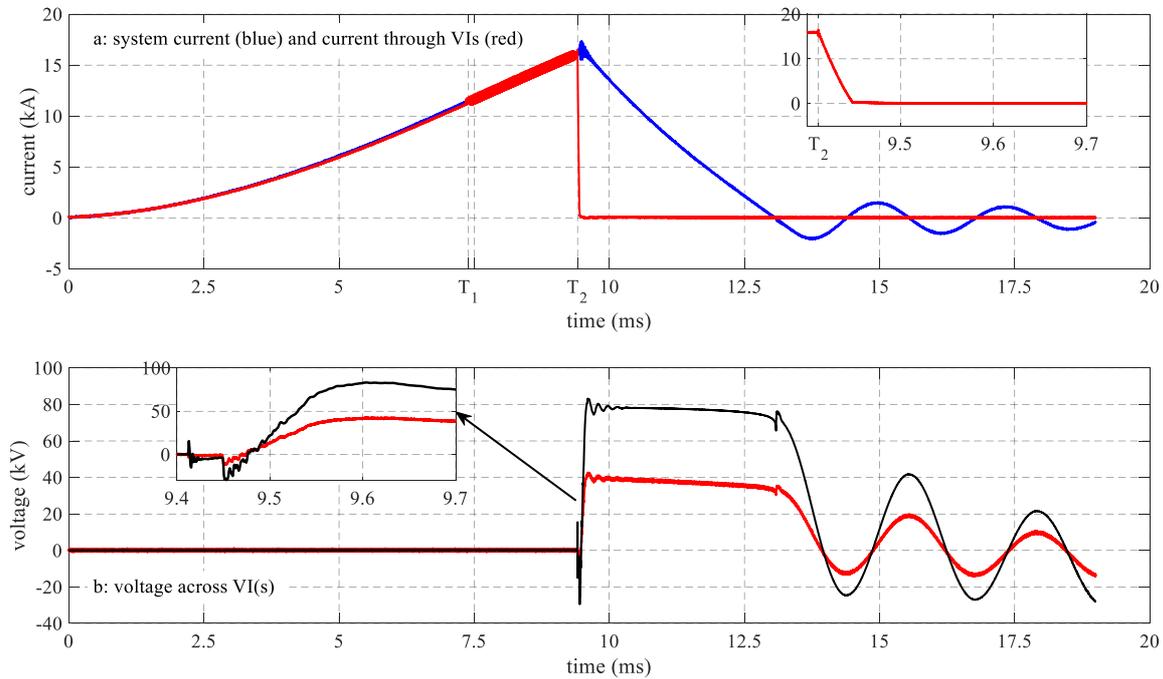
Test duty 3 is performed 6 times and only in one case a restrike and, subsequently, failure to interrupt occurred. A typical test result using double interrupter of VCB type C is shown in Figure 3-27. The arcing duration is set to 2 ms in this case. A very important point to note in this figure is the voltage sharing among the two VIs right from the moment of current interruption (see the zoomed section of Figure 3-27b). The VI<sub>1</sub> (see the red trace) takes about 51 % of the total voltage measured across both VIs (shown by the black trace). The remaining 4 test results with arcing duration of 2 ms also show quite similar voltage sharing.

Figure 3-27: Test duty 3 current interruption by double interrupter VCB type C. Better voltage distribution using 2500 pF grading capacitor

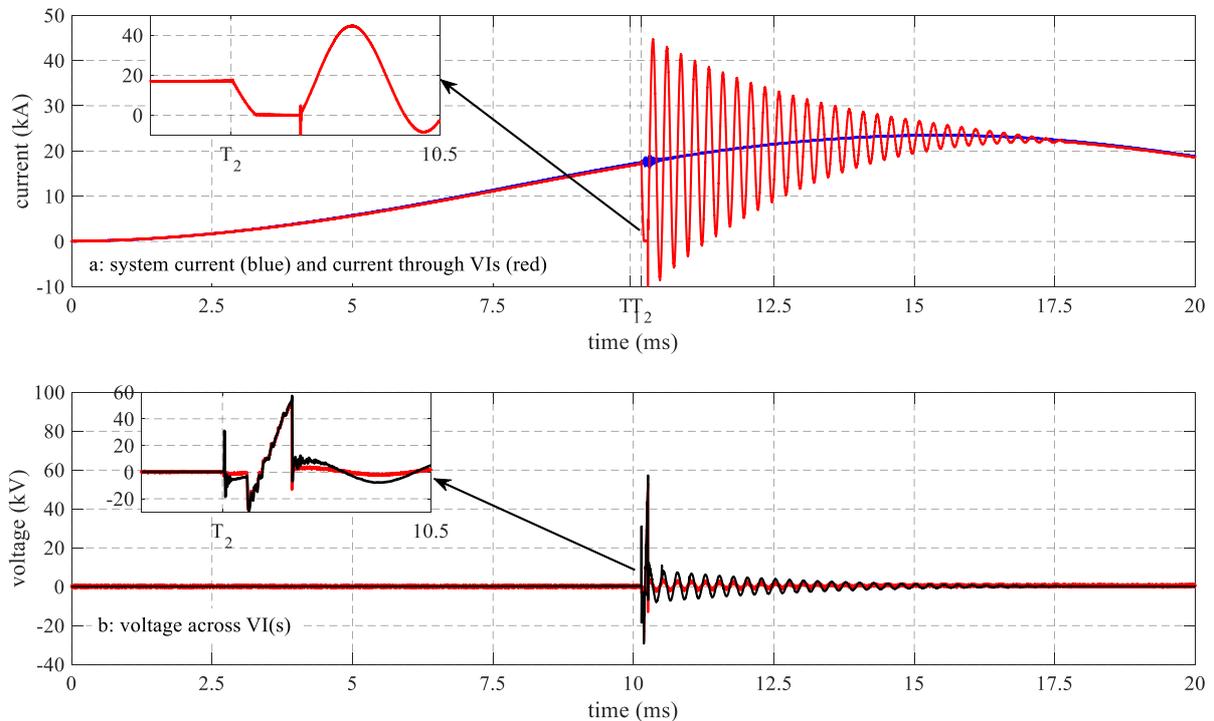
Figure 3-28: Test duty 3 failed current interruption by double interrupter VCB type C

Figure 3-28 shows a failed test duty 2 current interruption. In this case the arcing duration was extremely short, 0.2 ms. In this case only VI<sub>1</sub> cleared as can be observed from the voltage plots. The VI<sub>1</sub> sustained the ITIV of about 28 kV and it re-struck when the TIV rises to about 54 kV. In this case it could be possible that VI<sub>2</sub> could still

be in a closed position while only  $VI_1$  is clearing due to the very short arcing duration caused by the dispersion in the moment of contact separation. A very important observation similar to the single interrupter case of this VCB is that the VIs could not clear even if 8 CZCs are created after the restrike. This is typical observation for this VCB type.

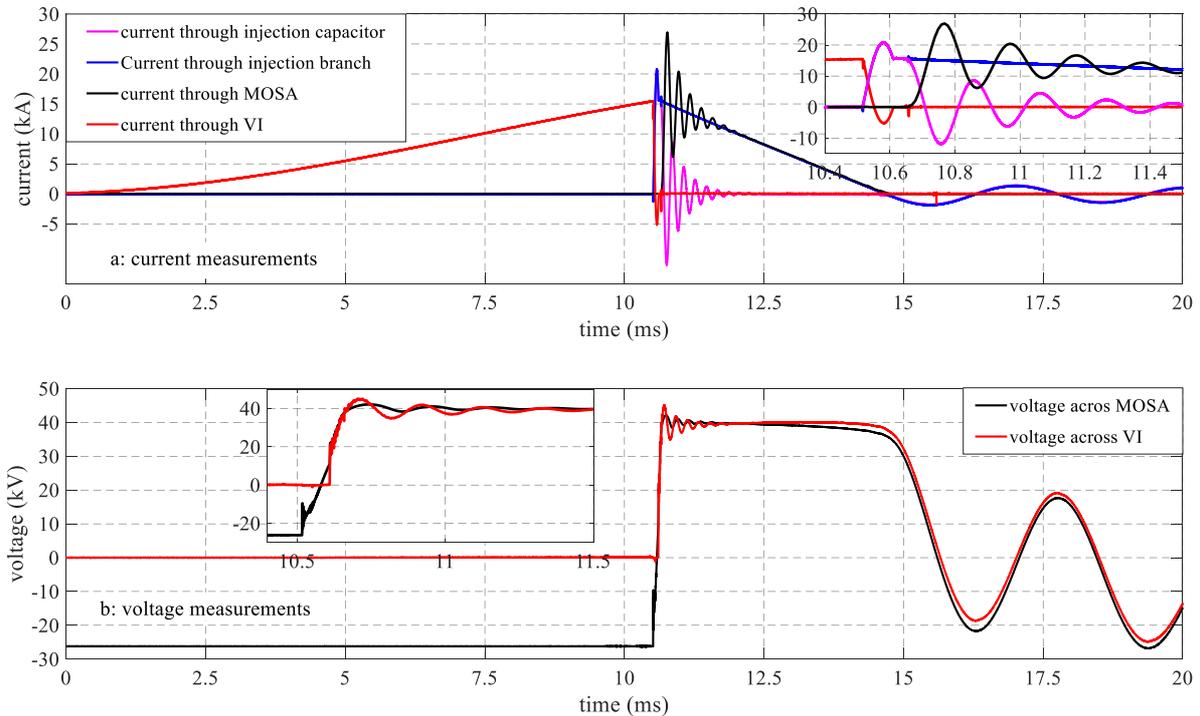
Figure 3-29 depicts a typical test result showing current commutation to the MOSA branch. The negative voltage across the MOSA is the pre-charge voltage across the injection capacitor which is applied to the MOSA as well.

Figure 3-29: Internal current commutation of experimental DC CB – current through MOSA

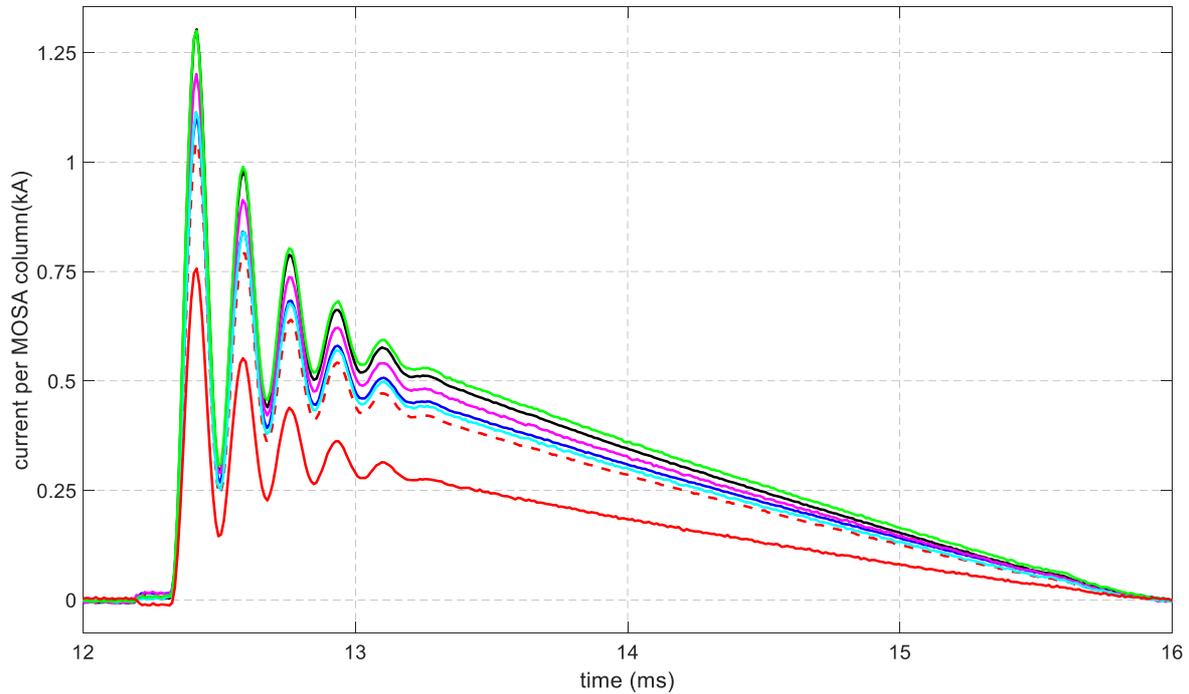
The MOSA conducts current for about 4 ms in this case while maintaining the voltage above 36 kV. In doing so, the MOSA absorbs the energy of about 1.3 MJ from the system. In addition to the total current through the MOSA, the currents through 8 of its columns are also measured. Typical currents through MOSA columns are shown in Figure 3-30. It can be seen that the current through the MOSA columns are not equal. Especially, the deviation between the column currents increases as the temperature of the MOSA increases. The temperature difference is enhanced due to differences in cooling of MOSA columns caused by the arrangement of the columns. The columns located in the middle have less ventilation compared to the columns located at the edges. This was an observation from the test results.

Figure 3-30: Typical current distribution among MOSA columns during energy absorption (current sharing issue)

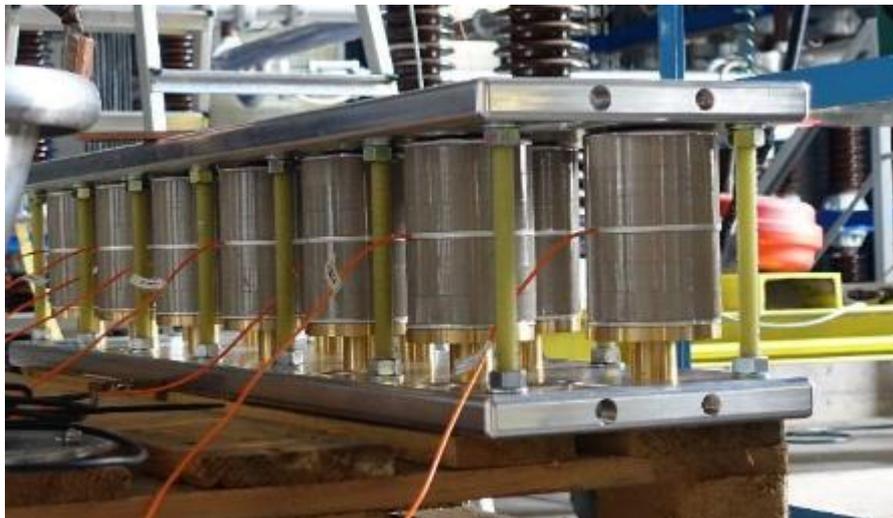
In addition to the current and voltage measurements, the temperature of 8 columns of the MOSA is measured. Figure 3-31 shows the MOSA module with 8 fibre optic based temperature sensors mounted. The sensors are placed at the centre of each column as this is typically the hottest spot.

Figure 3-31: FO temperature sensor connections to MOSA columns

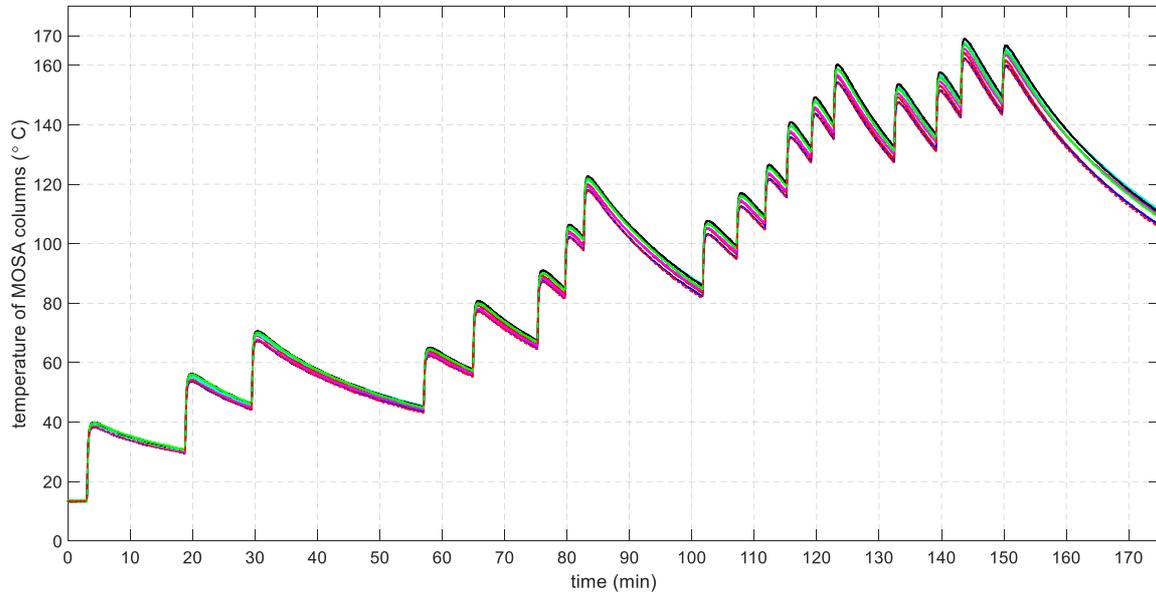
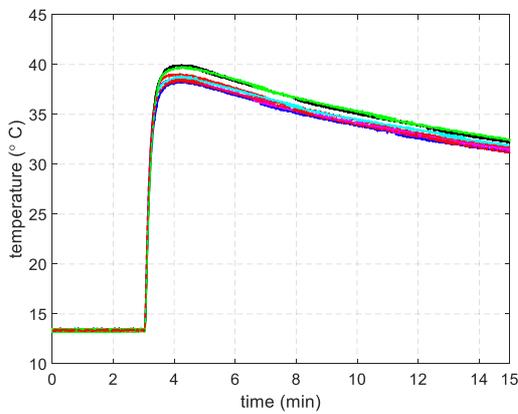
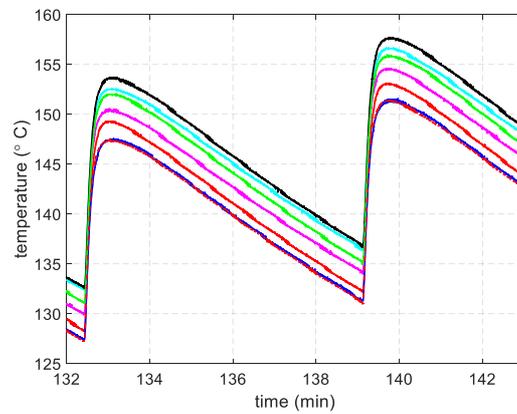
Figure 3-32a shows the MOSA temperature measurements by the FO sensors over 20 consecutive test shots. Tests were repeated until the temperature of the MOSA reaches around 170 °C. The MOSA did not show any sign of failure. However, the temperature differences between the columns increase as the MOSA is heated by injection of energy while the increase in the temperature at a given energy injection slightly reduced. This can be seen from Figure 3-32b and c. Figure 3-32b shows temperature rise of 26 °C in MOSA columns when 0.85 MJ

energy is injected on the first test whereas Figure 3-32c shows temperature rise of about 21 °C for approximately the same amount of energy except the initial temperature of MOSA in the latter case is around 130 °C. This reduced temperature rise is due to the increase in heat capacity of MOSA with temperature.

a)

b)

c)

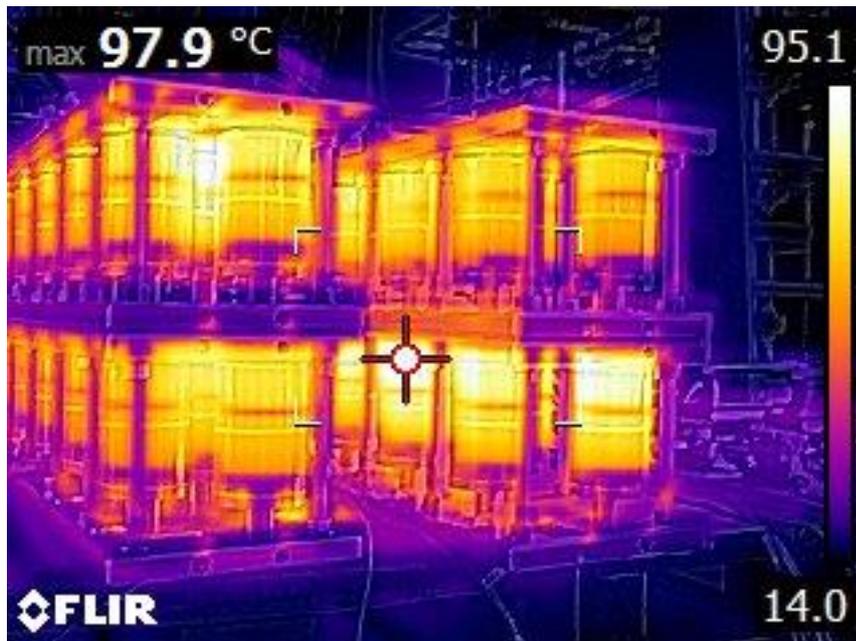
Figure 3-33 and Figure 3-34 show the temperature reading captured by the thermal imaging camera at different times during the test campaign. It can be seen from the thermal images that the temperature distribution is uniform throughout the columns. In general, there was no occasion where extreme temperature differences or extreme current sharing issue is recorded.

Figure 3-33: Thermal image of MOSA during experimental test campaign – double interrupter test case where two parallel sets are used

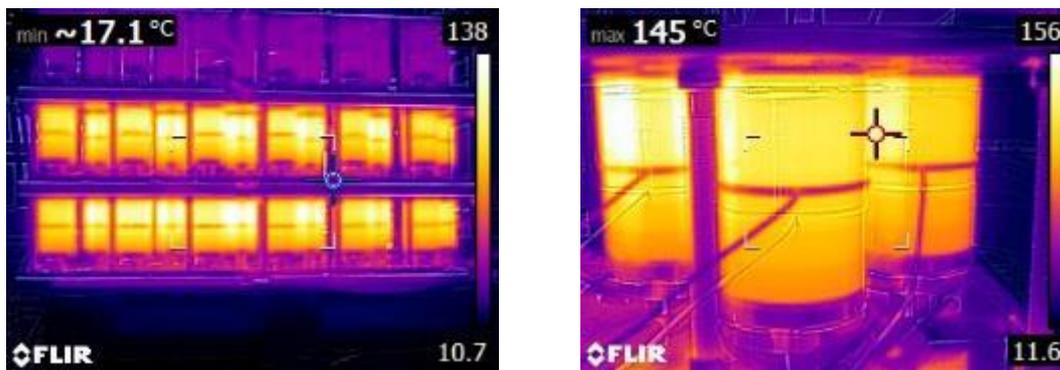
Figure 3-34: Thermal image of MOSA for double break DC CB

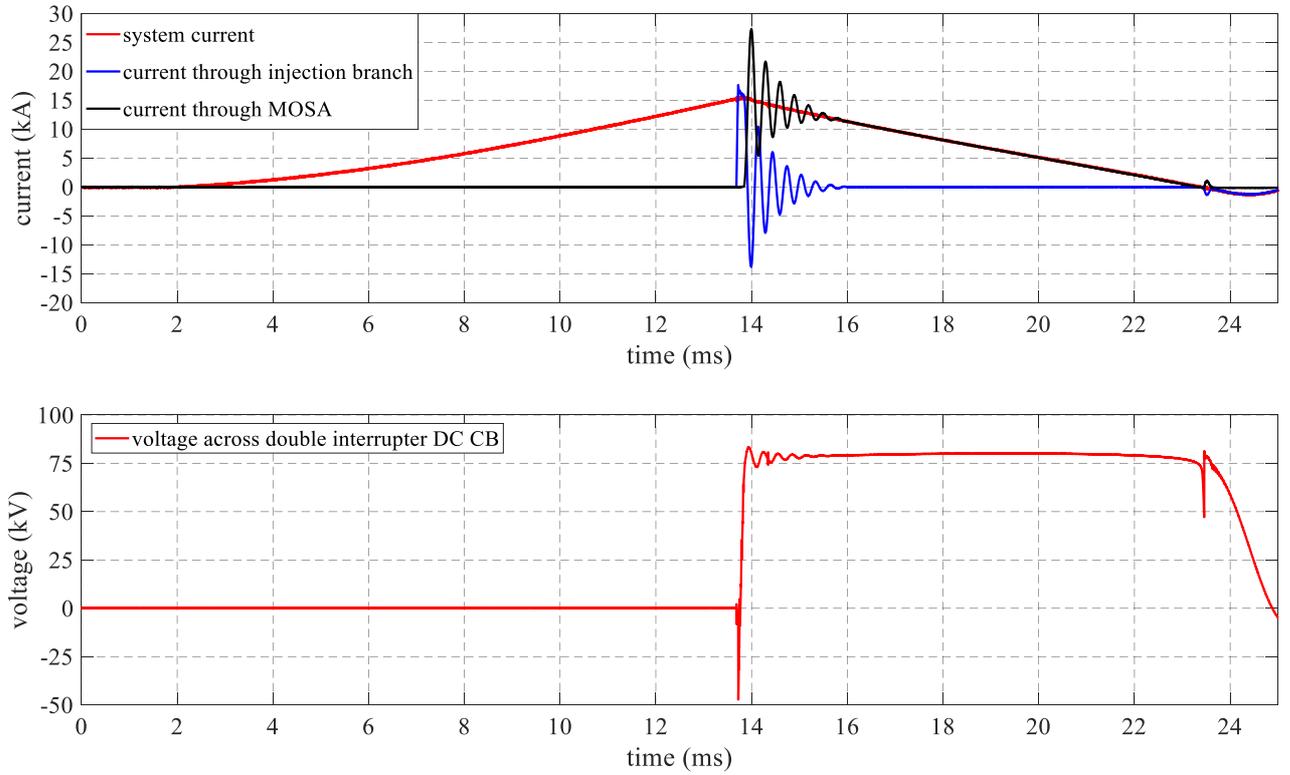
A test result shown Figure 3-35 is one of the cases where high-energy absorption is performed. It can be seen that the MOSA is conducting current for about 10 ms which is usually long duration compared to its conventional application in AC systems. While MOSA is conducting or absorbing energy for about 10 ms, the TIV appears across the two VIs (since this was a double interrupter case) for the same duration. In this case the energy of about 5.3 MJ is absorbed by two series connected MOSA banks. This is shown in Figure 3-36.

Figure 3-35: High-energy test result

It must be noted that during the repeated energy injections discussed above, the maximum energy absorbed by MOSA at a time was about 1.3 MJ which is about half the amount it can handle. This was intended not to over heat the MOSA while repeating as many tests as possible within a short period of time. Later a few test shots were performed to inject 2.5 MJ energy per MOSA bank. This results in energy per volume of  $200 \text{ j/cm}^3$  which assumed to be acceptable by MOSA.

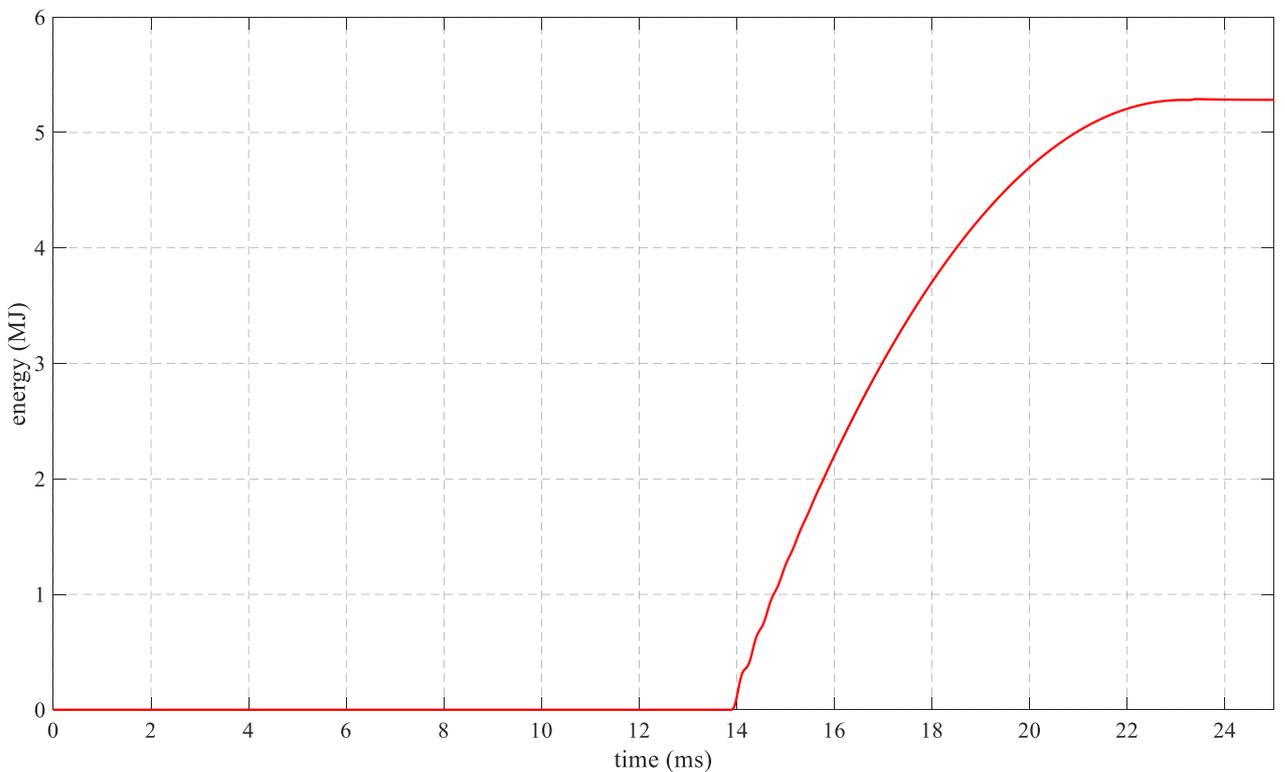
Figure 3-36: energy absorption by MOSA during high-energy test

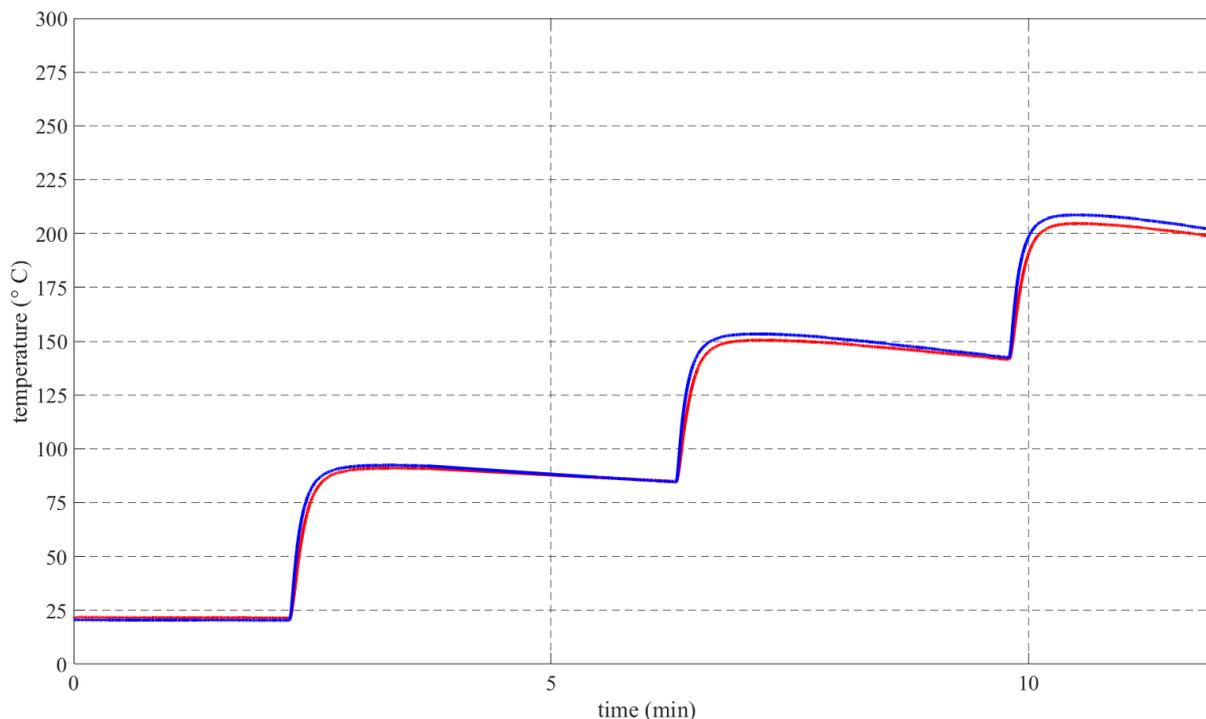
Figure 3-37 shows temperature rise across the MOSA during three successive high-energy absorption tests. In this case a temperature rise by 72 °C is observed in the first test. In the next test temperature rise of 67 °C is observed for nearly the same amount of energy. This shows that there is a change in the heat capacity of MO varistor discs with temperature. The higher the temperature, the higher the heat capacity. MOSA temperature raised to above 200 °C. In the fourth test the MOSA actually failed to absorb energy where a few MO varistor disks exploded.

Figure 3-37: Temperature measurement during three successive high-energy tests.
