# D10.4: Document on Test Result Analysis

PROMOTioN – Progress on Meshed HVDC Offshore Transmission Networks  
Mail [info@promotion-offshore.net](mailto:info@promotion-offshore.net)  
Web [www.promotion-offshore.net](http://www.promotion-offshore.net)

**Document Name:** Document on Test Result Analysis  
**Responsible partner:** DNV GL  
**Work Package:** WP10  
**Work Package leader:** Rene Smeets  
**Task:** 10.4  
**Task lead:** Nadew Belda

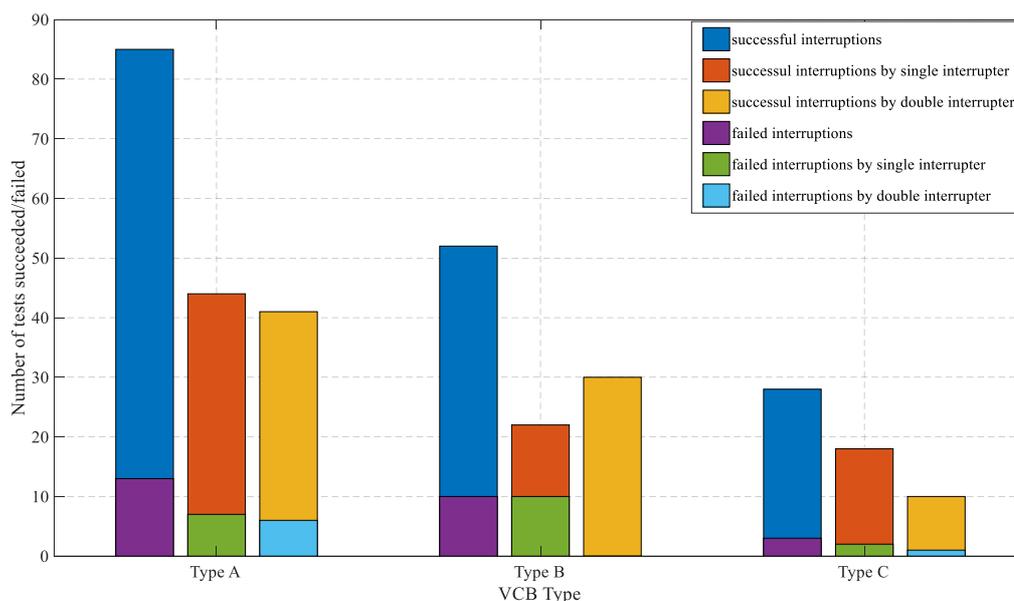
Finally, the statistical performance of the three VCBs used in the test campaign is presented in Figure 3-38, where for each VCB type the total number of successful current interruptions and failed current interruptions (for both single and double interrupter set-ups) and the total number of success and failure per single as well as double interrupter set-ups are presented. For VCB type B, even if its performance at the 1<sup>st</sup> CZC is much better than that of VCB type A, the percentage of failure at single interrupter case is higher. This is due to the dispersion of the

Figure 3-38: General test results statistical information
